### Deed of Preservation and Conservation Easement

**UPSALA**  
6430 Germantown Avenue  
Philadelphia, PA 19119

**WHEREAS**, Upsala includes a masonry house (the "House"), comprised of a main block (the "Main Block"), rear ell (the "Ell"), and addition to the Ell (the "Rear Extension") dating to 1798;

**1.2 Baseline Documentation.** Upsala's conservation and preservation values are documented in photographs, floor plans, a site plan, and the Archaeological Report contained or referenced in Exhibit B (hereinafter "Baseline Documentation") incorporated herein by reference, which Baseline Documentation the parties agree provides an accurate representation of the existing conditions of Upsala as of the effective date of this Easement. In the event of any discrepancy between the two (2) counterparts produced, the counterpart retained by Grantee shall control.

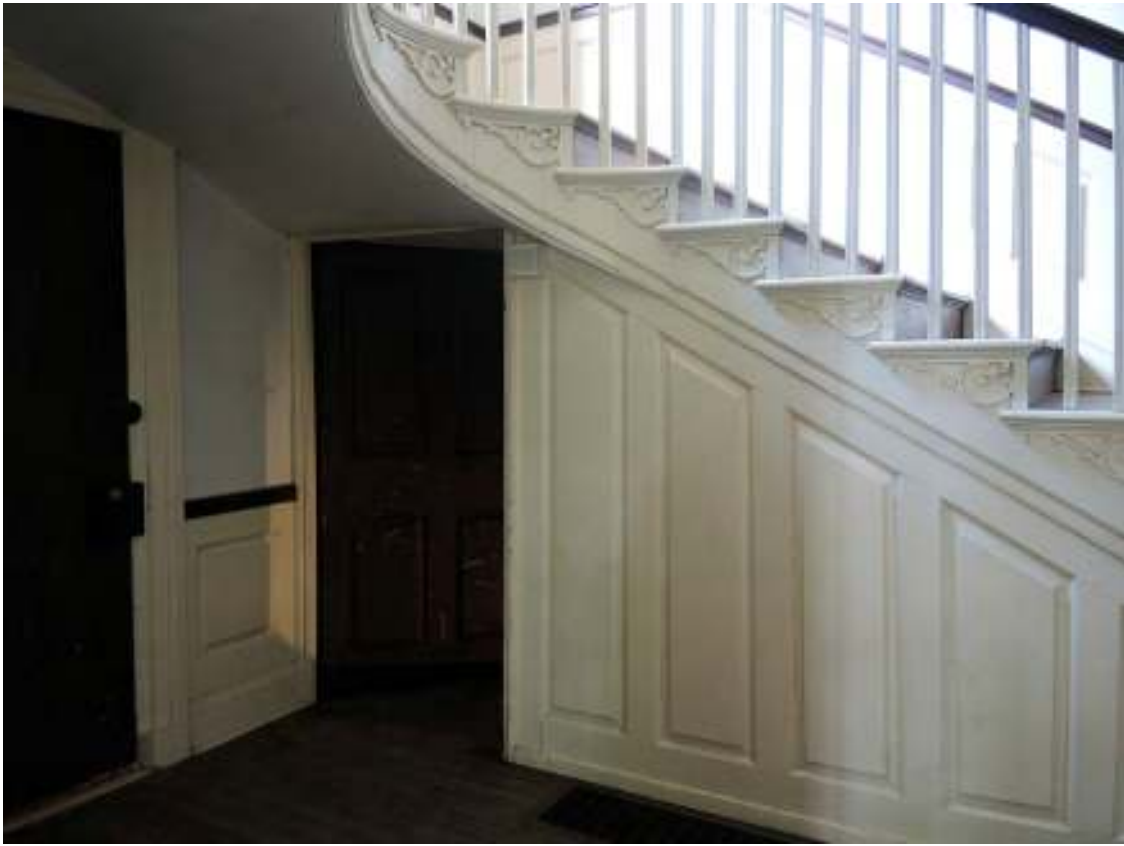
| 49 | Main Block Interior, Room 102, Looking West at Cellar Door; Cracks along Curved Stair Stringers (09-13-2016, NTHP) |

PHOTO 049 - Main Block Interior, Room 102, Looking West at Cellar Door; Cracks along Curved Stair Stringers (09-13-2016, NTHP)

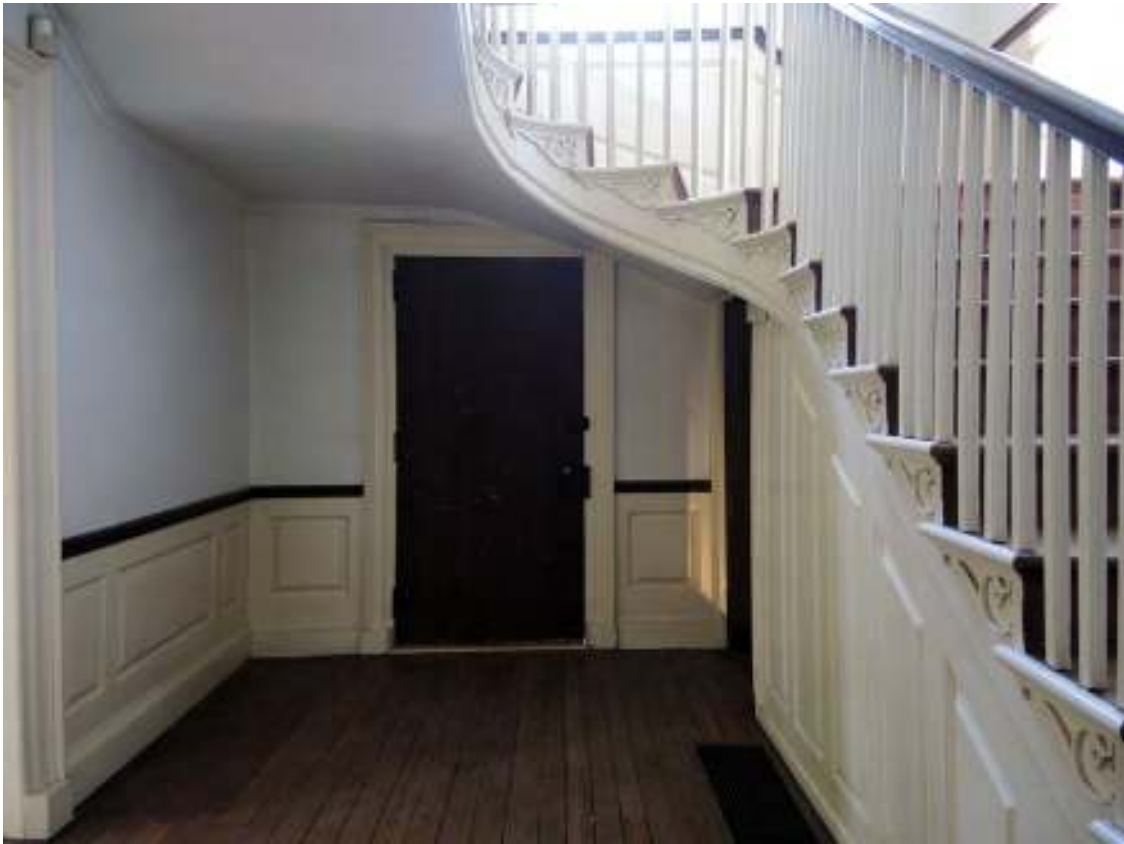
| 51 | Main Block Interior, Room 102, Looking Southwest; Cracked Plaster Underside of Staircase (09-13-2016, NTHP) |

PHOTO 051 - Main Block Interior, Room 102, Looking Southwest; Cracked Plaster Underside of Staircase (09-13-2016, NTHP)

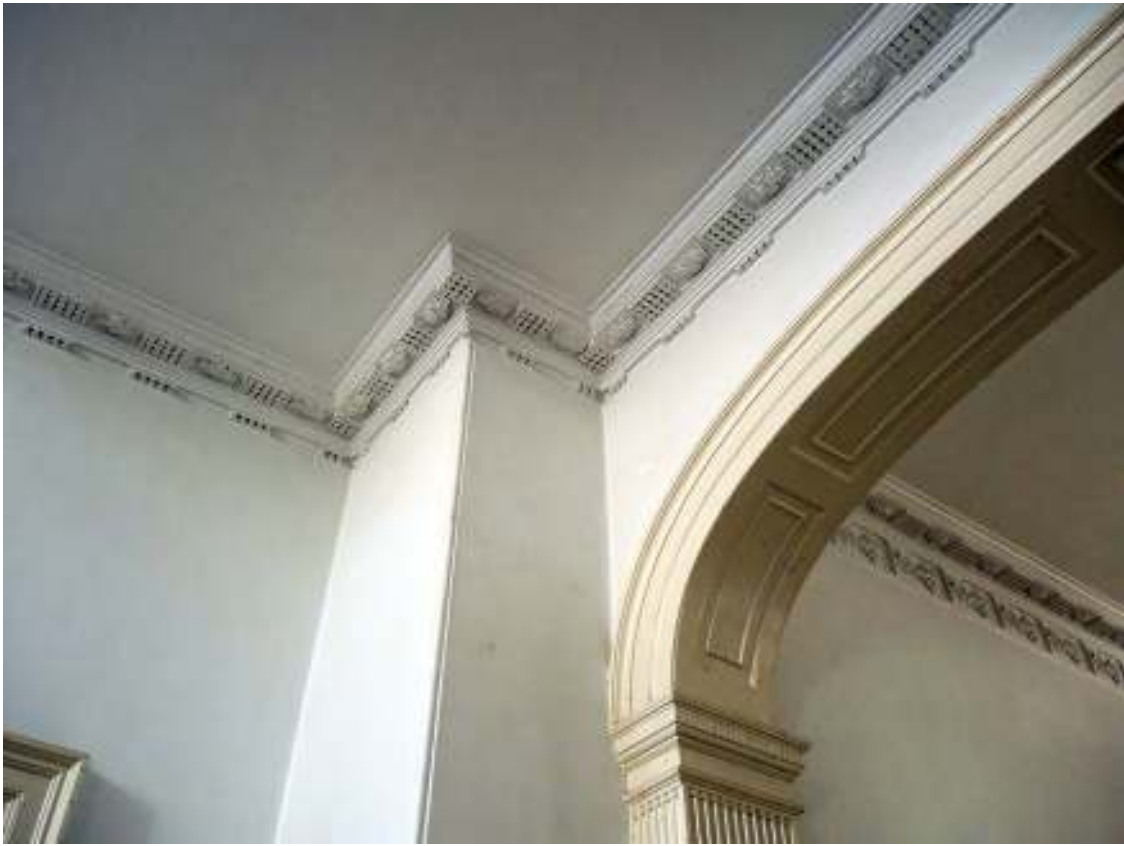
| 53 | Main Block Interior, Room 102, Detail of Plaster and Millwork; Crack in Northeast Corner of Wooden Arch (09-13-2016, NTHP) |

PHOTO 053 - Main Block Interior, Room 102, Detail of Plaster and Millwork; Crack in Northeast Corner of Wooden Arch (09-13-2016, NTHP)

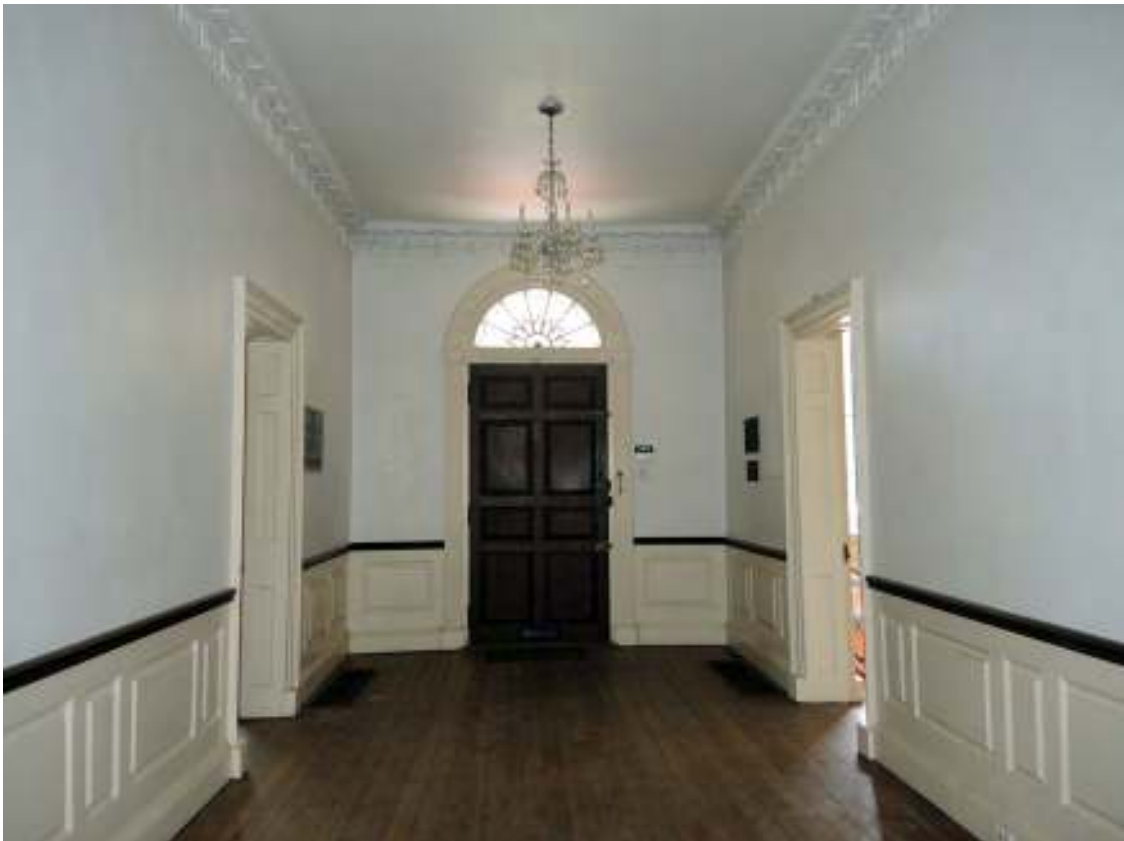
| 54 | Main Block Interior, Room 102, Looking Northeast; Plaster Crack in East Corner (09-13-2016, NTHP) |

PHOTO 054 - Main Block Interior, Room 102, Looking Northeast; Plaster Crack in East Corner (09-13-2016, NTHP)

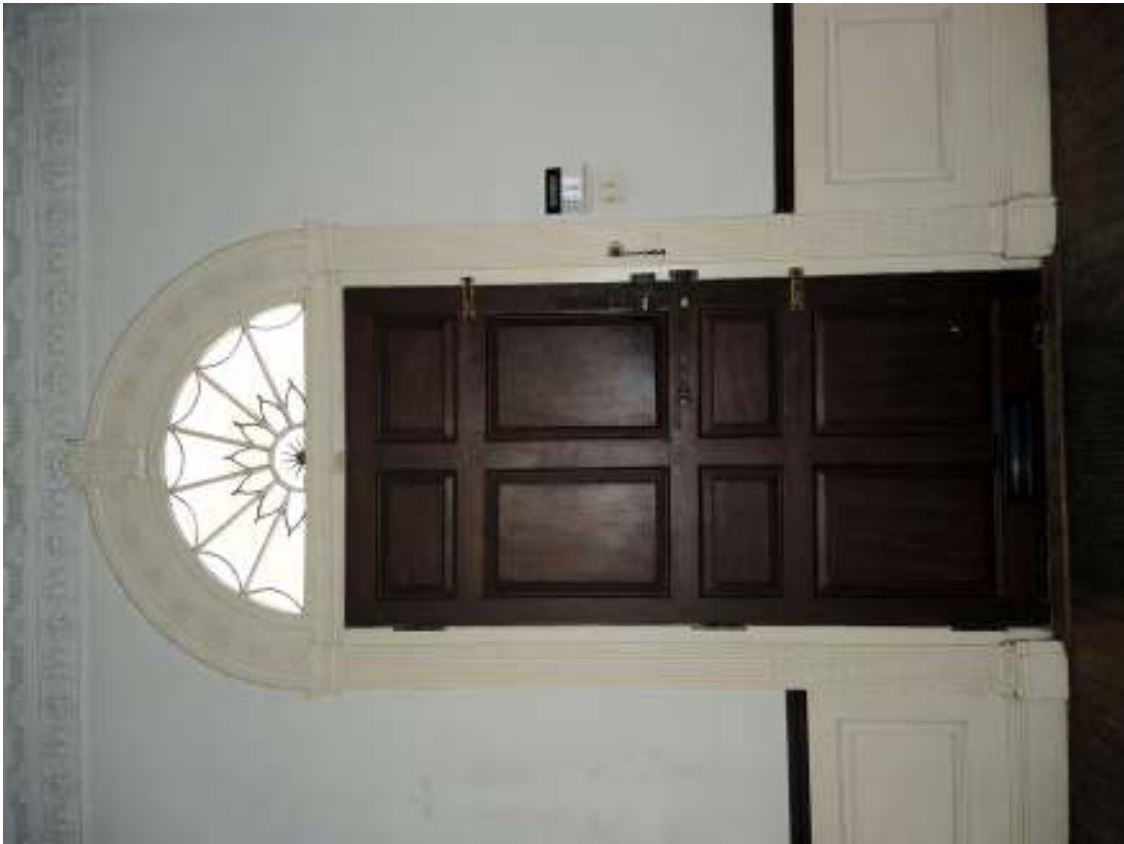
| 55 | Main Block Interior, Room 102, Detail of Entry Door; Cracked Plaster above Fanlight Keystone (09-14-2016, NTHP) |

PHOTO 055 - Main Block Interior, Room 102, Detail of Entry Door; Cracked Plaster above Fanlight Keystone (09-14-2016, NTHP)

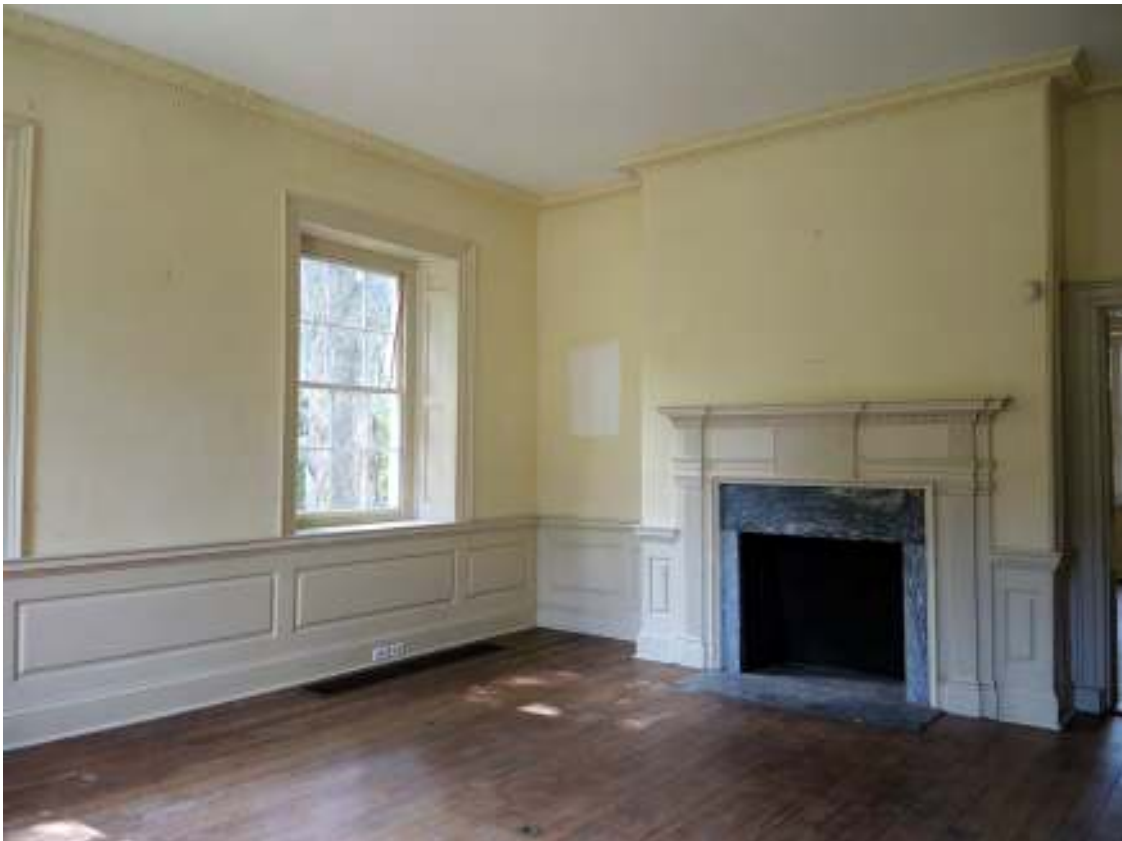
| 60 | Main Block Interior, Room 101, Southeast Corner; Gap in Top Rail & Wainscoting at Corner, Plaster Molding Damage at East Wall (09-13-2016, NTHP) |

PHOTO 060 - Main Block Interior, Room 101, Southeast Corner; Gap in Top Rail & Wainscotting at Corner, Plaster Molding Damage at East...

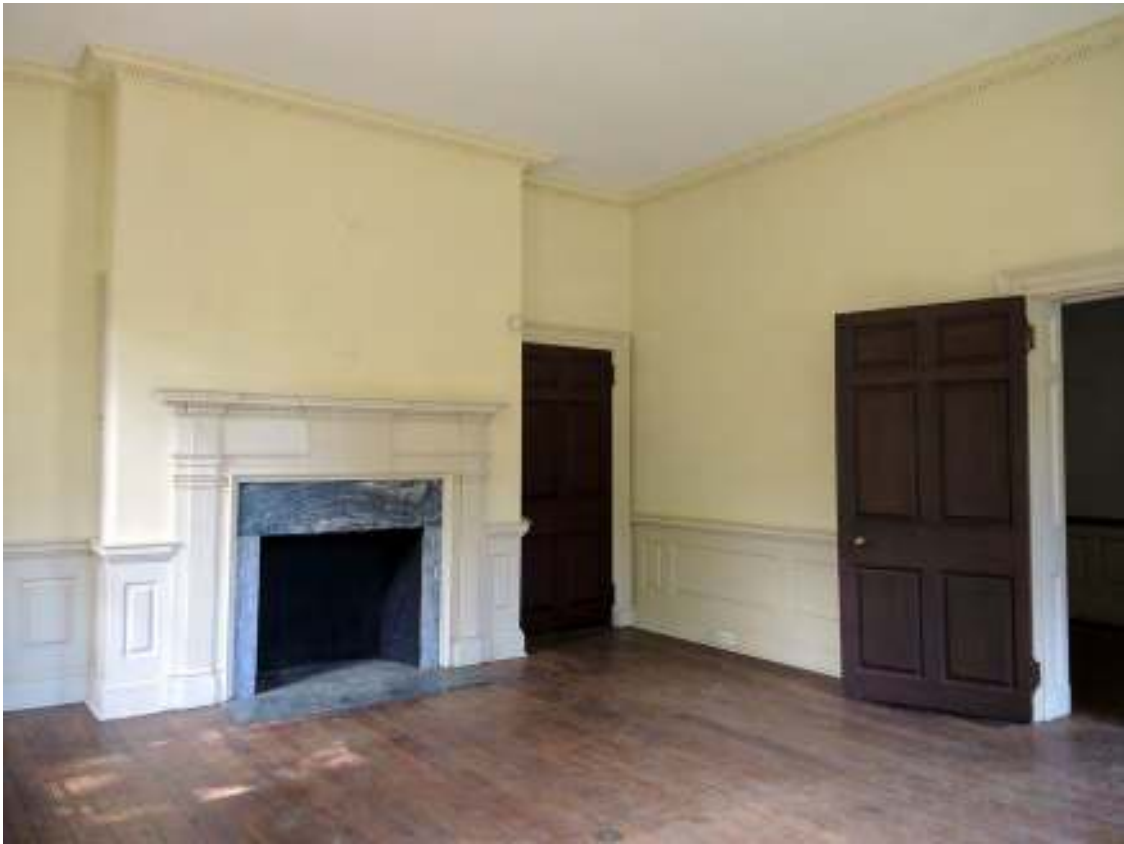
| 61 | Main Block Interior, Room 101, Southwest Corner; Cracks in Stone Fireplace Surround (09-13-2016, NTHP) |

PHOTO 061 - Main Block Interior, Room 101, Southwest Corner; Cracks in Stone Fireplace Surround (09-13-2016, NTHP)

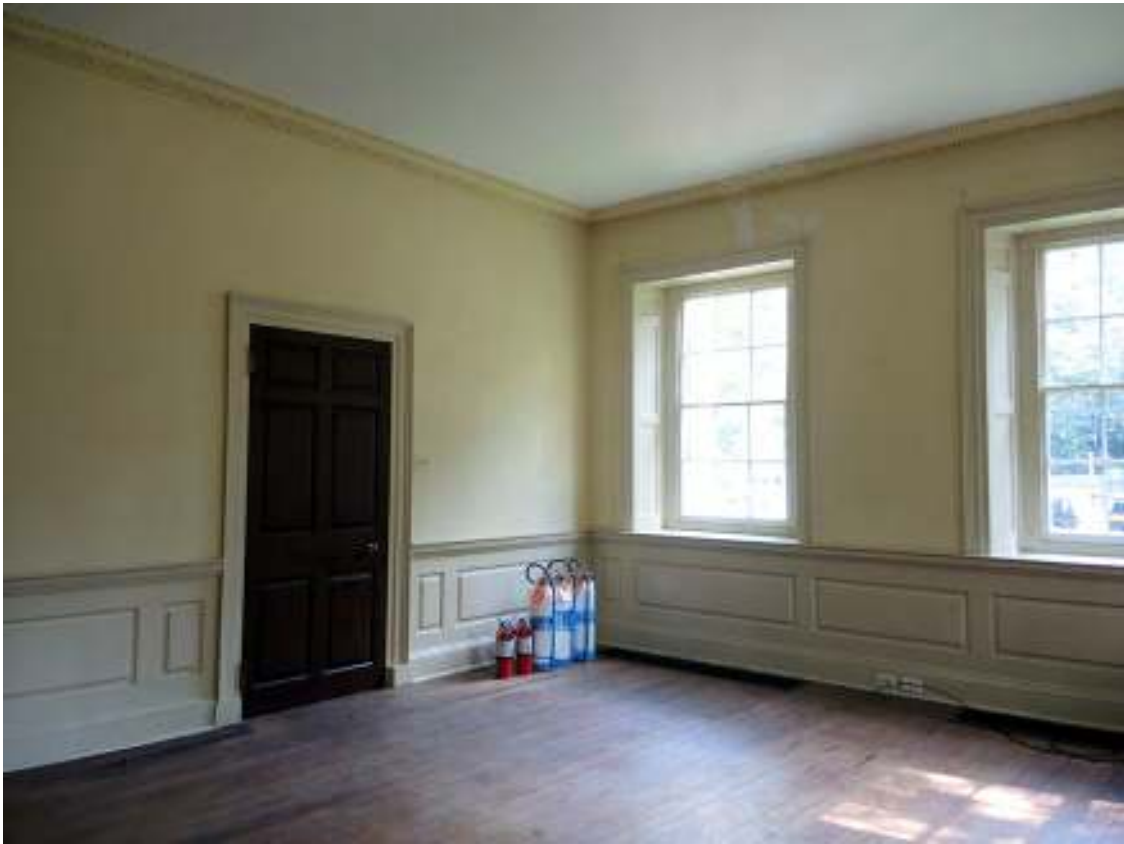
| 63 | Main Block Interior, Room 101, Northwest Corner; Plaster Molding Damage on North Wall (09-13-2016, NTHP) |

PHOTO 063 - Main Block Interior, Room 101, Northwest Corner; Plaster Molding Damage on North Wall (09-13-2016, NTHP)

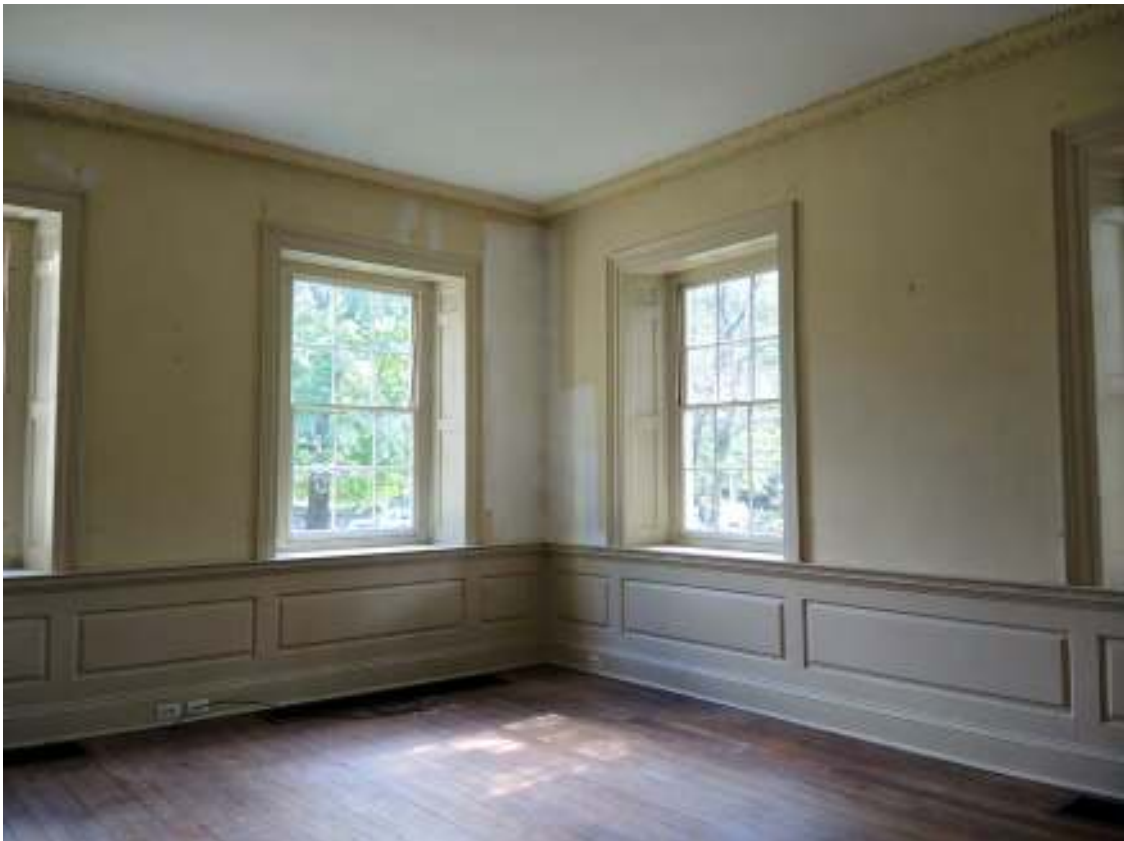
| 64 | Main Block Interior, Room 101, Northeast Corner; Plaster Damage on North Wall and Molding (09-13-2016, NTHP) |

PHOTO 064 - Main Block Interior, Room 101, Northeast Corner; Plaster Damage on North Wall and Molding (09-13-2016, NTHP)

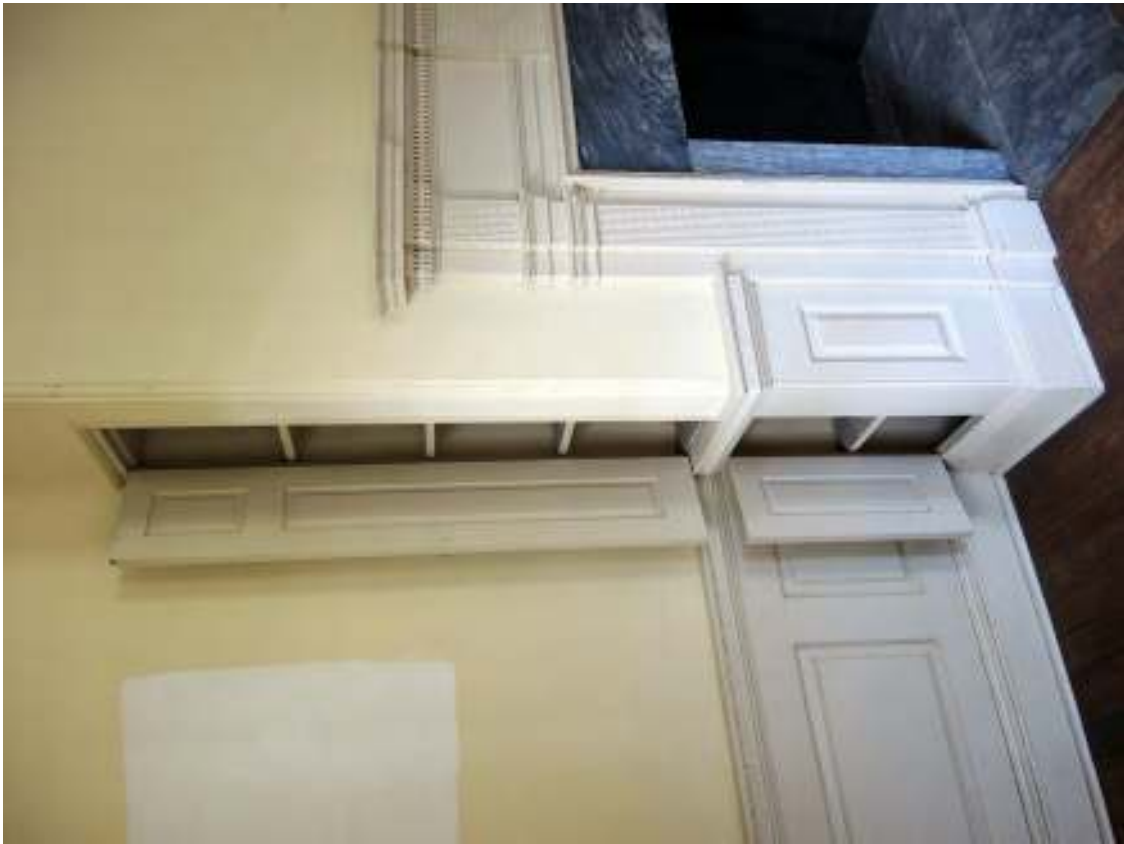
| 65 | Main Block Interior, Room 101, Detail of East Cabinet; Cracked Paint along side of Fireplace Mantel (09-13-2016, NTHP) |

PHOTO 065 - Main Block Interior, Room 101, Detail of East Cabinet; Cracked Paint along side of Fireplace Mantel (09-13-2016, NTHP)

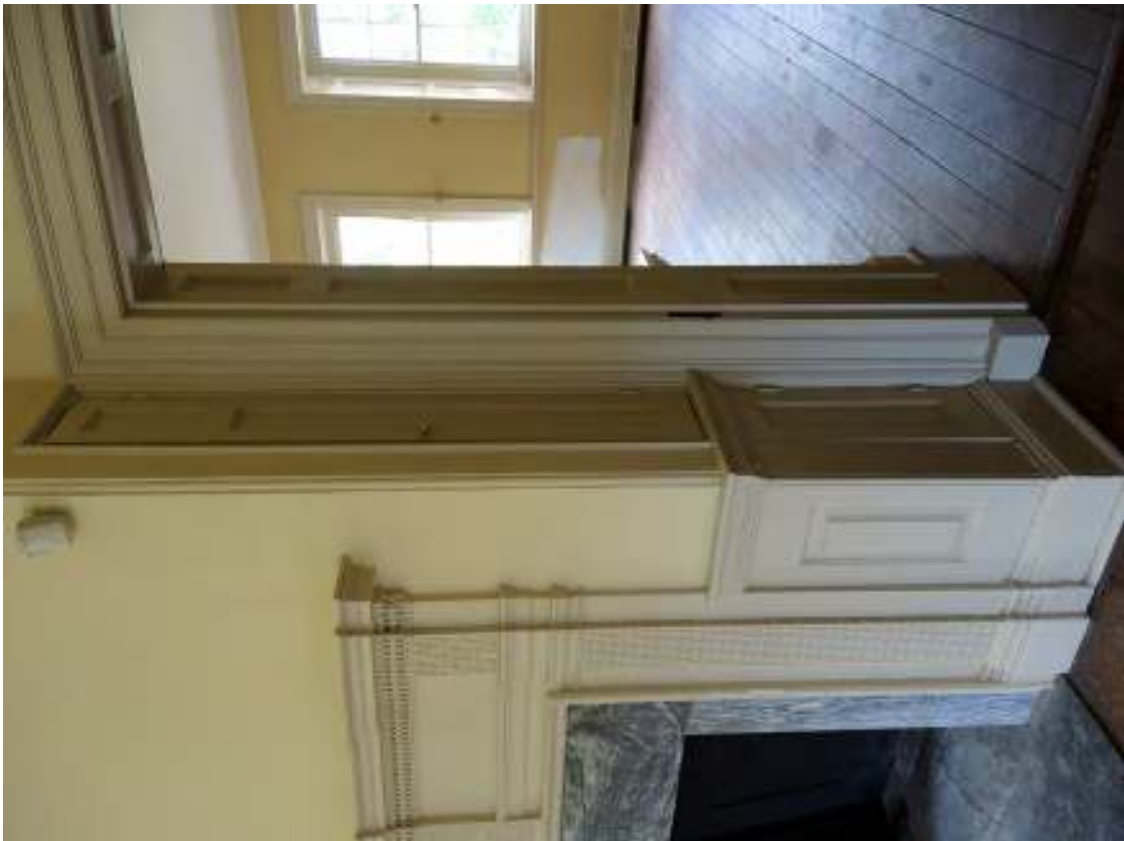
| 66 | Main Block Interior, Room 101, Detail of West Cabinet; Cracked Plaster and Paint along side of Fireplace Mantel (09-13-2016, NTHP) |

PHOTO 066 - Main Block Interior, Room 101, Detail of West Cabinet; Cracked Plaster and Paint along side of Fireplace Mantel (09-13-2016,...

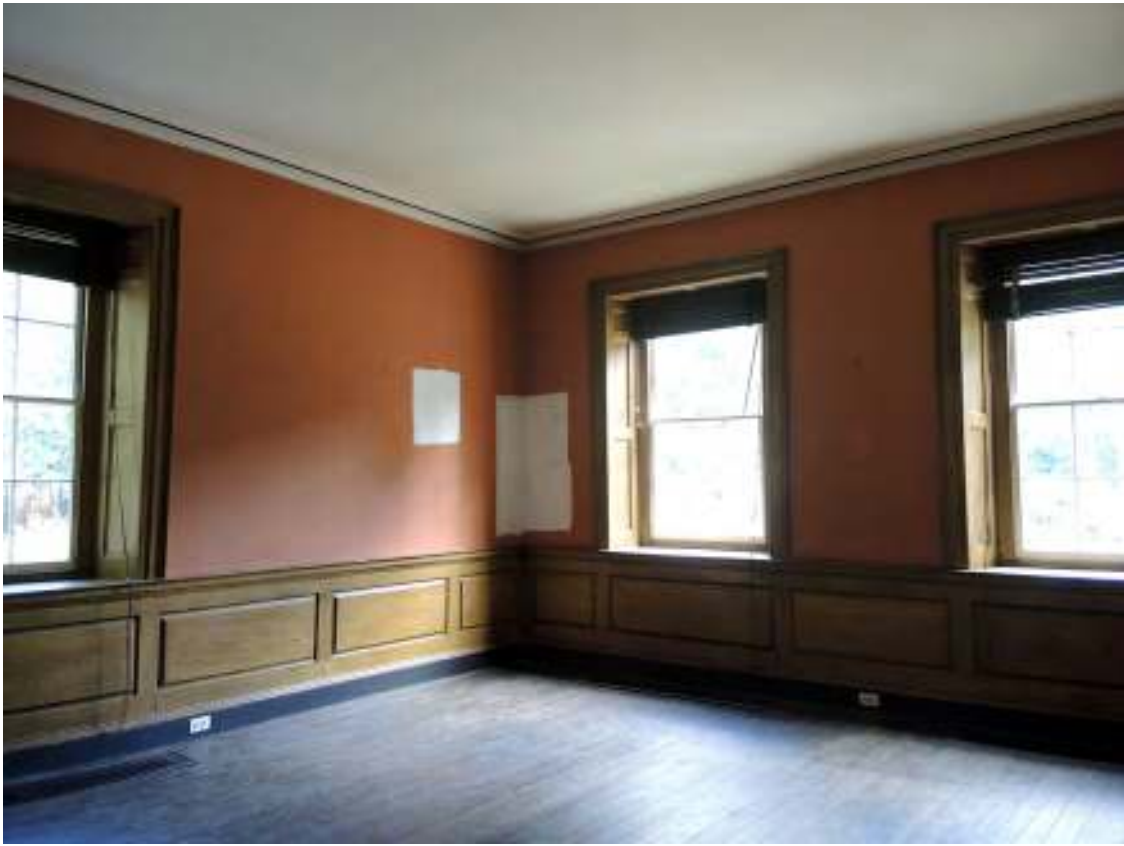
| 69 | Main Block Interior, Room 103, Northwest Corner; Uneven Floor at West Wall, Cracked Plaster Molding, Window Sill Damage on North Wall (09-13-2016, NTHP) |

PHOTO 069 - Main Block Interior, Room 103, Northwest Corner; Uneven Floor at West Wall, Cracked Plaster Molding, Window Sill Damage...

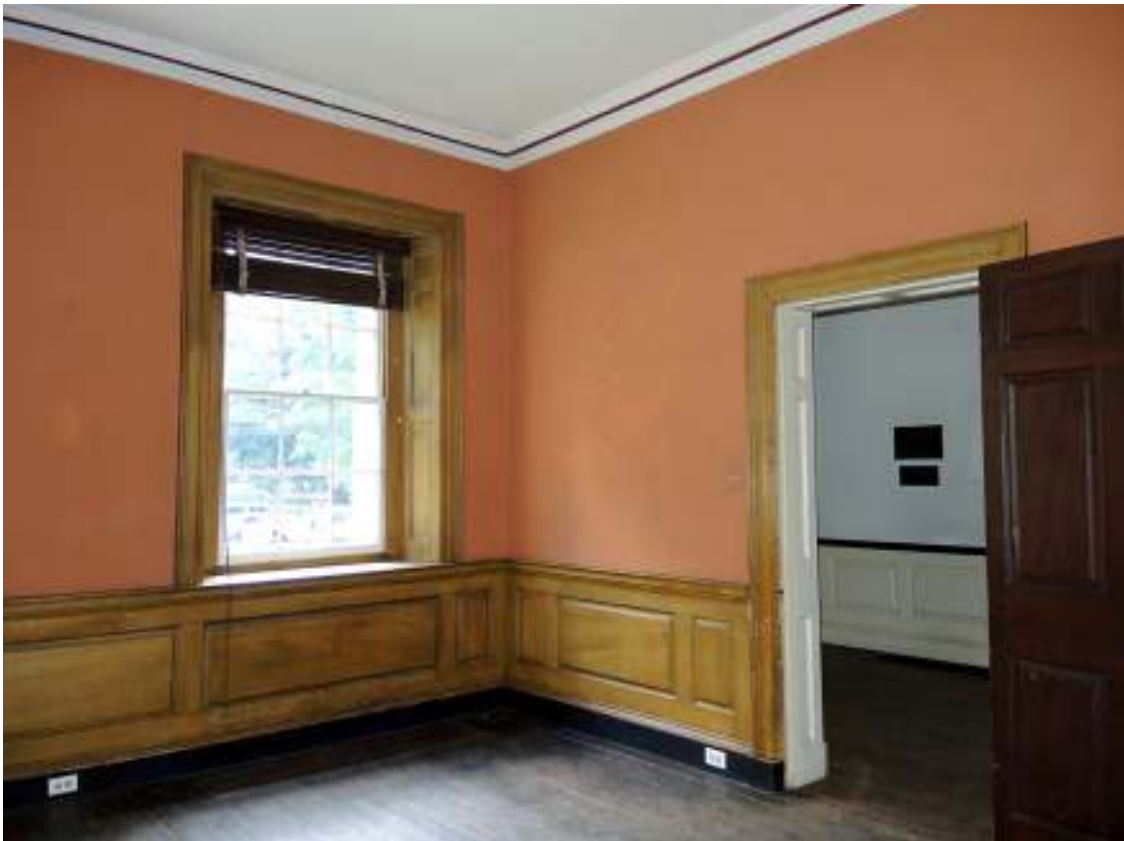
| 70 | Main Block Interior, Room 103, Northeast Corner; Uneven Wood Floor at East Wall, Window Sill Damage, Cracked Plaster in Ceiling (09-13-2016, NTHP) |

PHOTO 070 - Main Block Interior, Room 103, Northeast Corner; Uneven Wood Floor at East Wall, Window Sill Damage, Cracked Plaster in ...

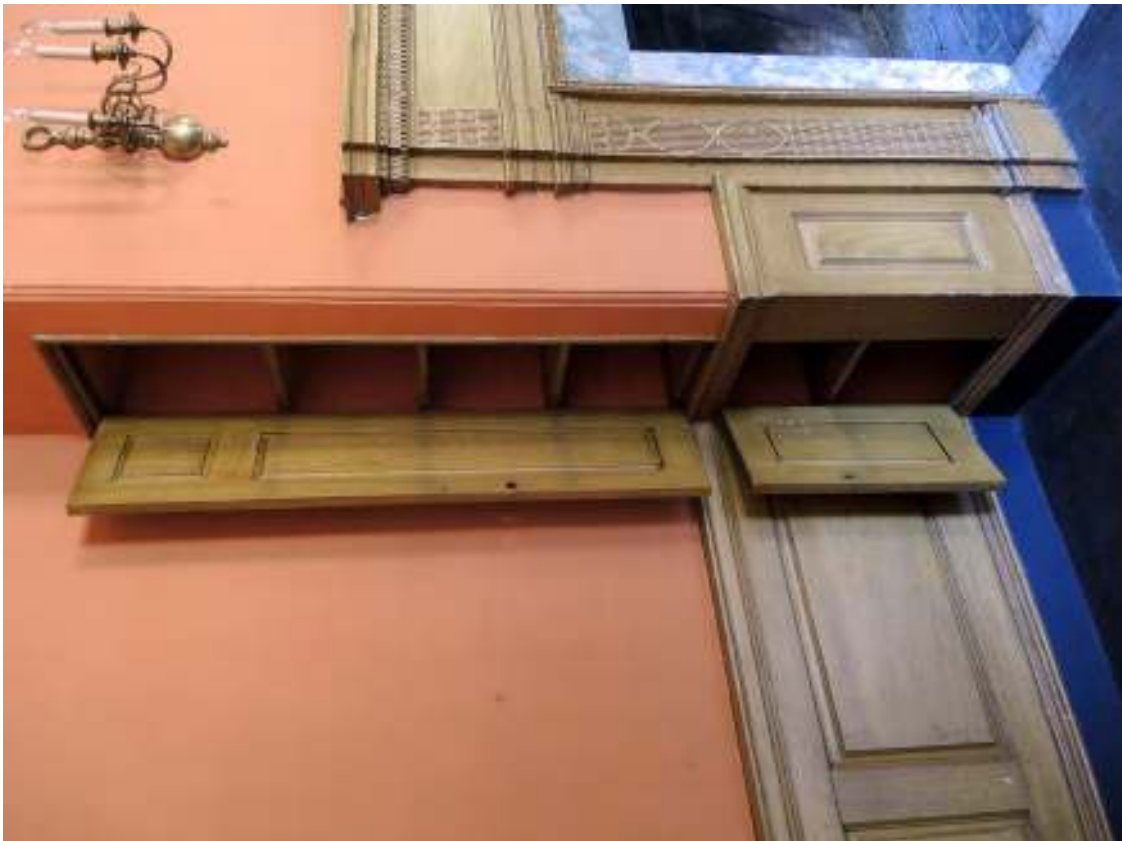
| 72 | Main Block Interior, Room 103, Detail of East Cabinet; Cabinet Hardware Missing (09-13-2016, NTHP) |

PHOTO 072 - Main Block Interior, Room 103, Detail of East Cabinet; Cabinet Hardware Missing (09-13-2016, NTHP)

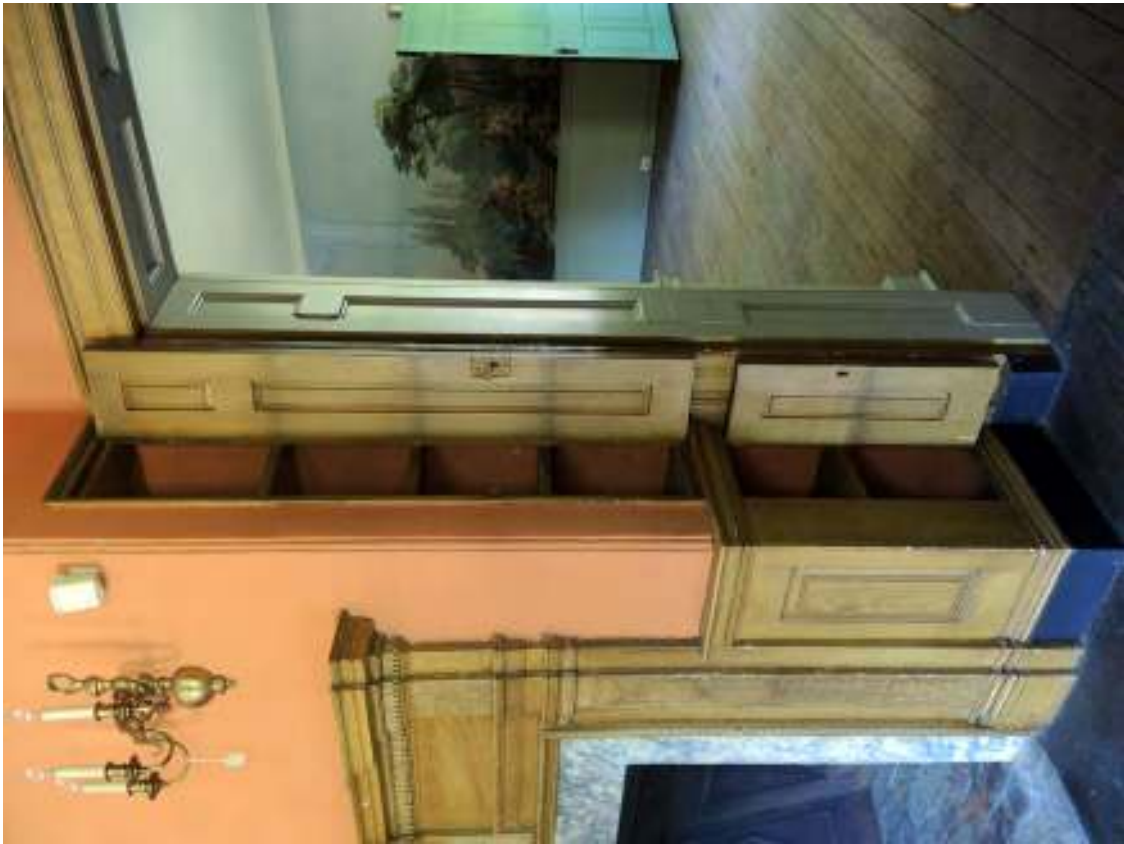
| 73 | Main Block Interior, Room 103, Detail of West Cabinet; Cabinet Hardware Missing (09-13-2016, NTHP) |

PHOTO 073 - Main Block Interior, Room 103, Detail of West Cabinet; Cabinet Hardware Missing (09-13-2016, NTHP)

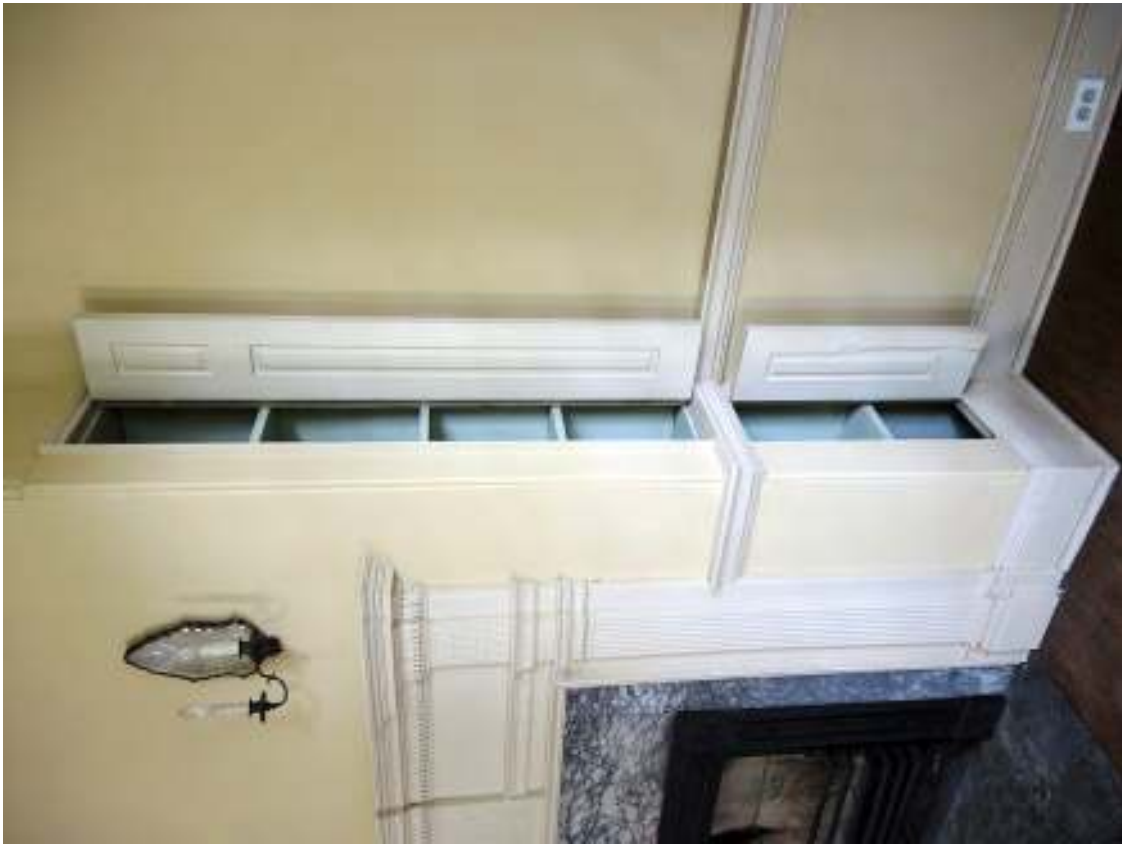
| 79 | Main Block Interior, Room 104, Detail of East Cabinet; Cracked Plaster Above Cabinet (09-13-2016, NTHP) |

PHOTO 079 - Main Block Interior, Room 104, Detail of East Cabinet; Cracked Plaster Above Cabinet (09-13-2016, NTHP)

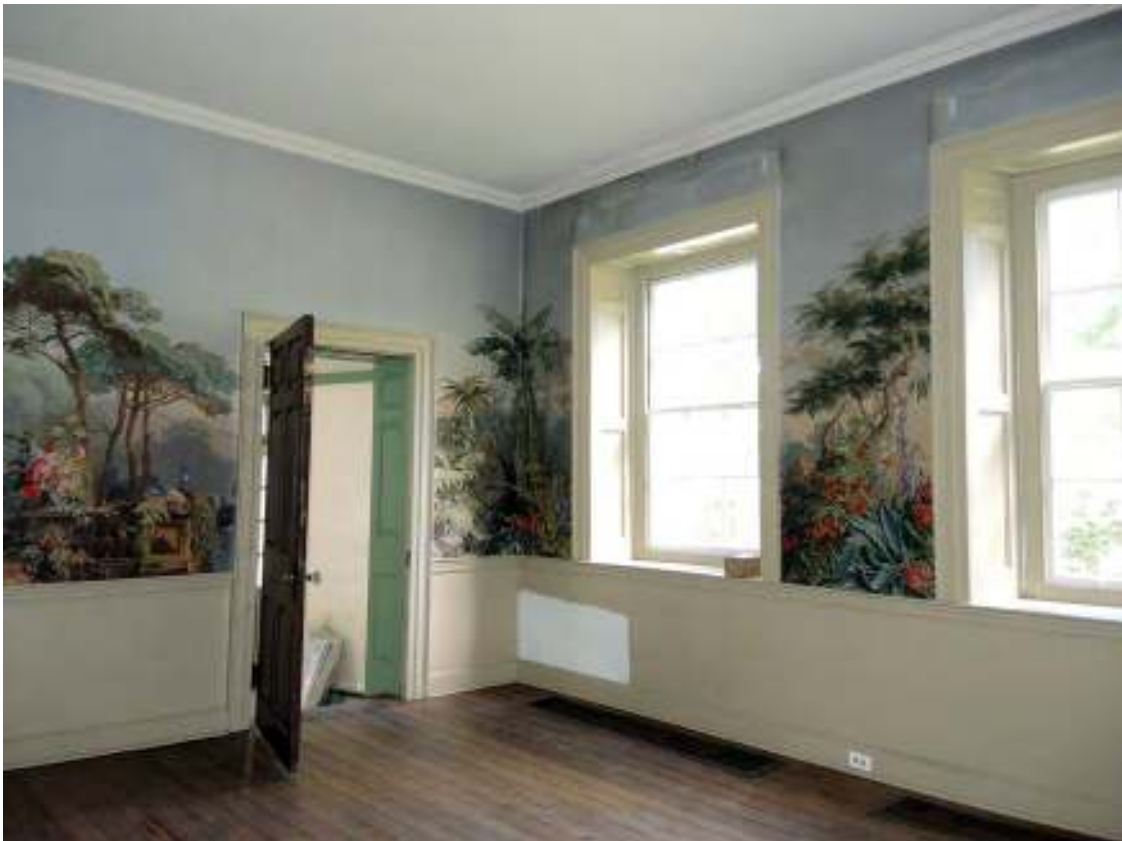
| 80 | Main Block Interior, Room 105, Southwest Corner; Plaster Molding & Ceiling Damage at Corner, Plaster Crack in West Ceiling (09-13-2016, NTHP) |

PHOTO 080 - Main Block Interior, Room 105, Southwest Corner; Plaster Molding & Ceiling Damage at Corner, Plaster Crack in West Ceiling...

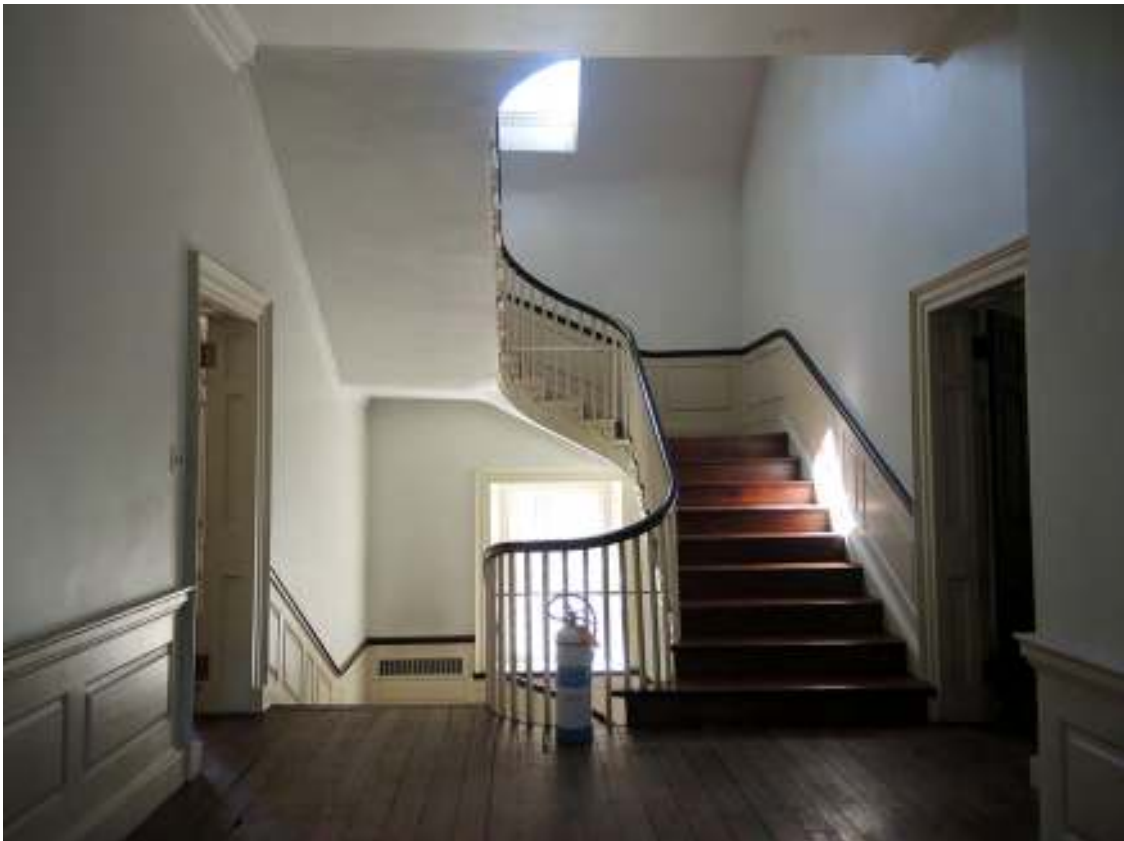
| 104 | Main Block Interior, Room 202, Looking Southwest; Cracks at Underside of Staircase Extending to East Wall above Door (09-14-2016, NTHP) |

PHOTO 104 - Main Block Interior, Room 202, Looking Southwest; Cracks at Underside of Staircase Extending to East Wall above Door (09-...

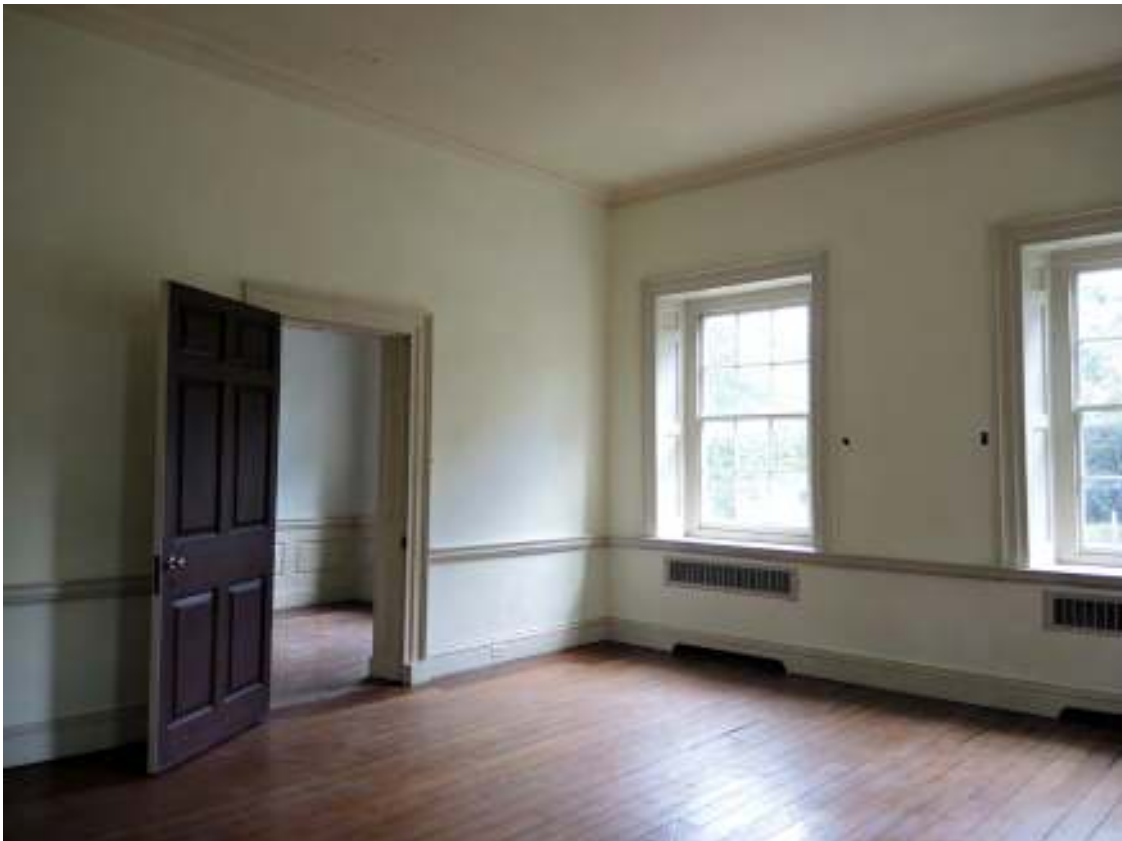
| 106 | Main Block Interior, Room 201, Northwest Corner; Plaster Molding Damage on West Wall (09-13-2016, NTHP) |

PHOTO 106 - Main Block Interior, Room 201, Northwest Corner; Plaster Molding Damage on West Wall (09-13-2016, NTHP)

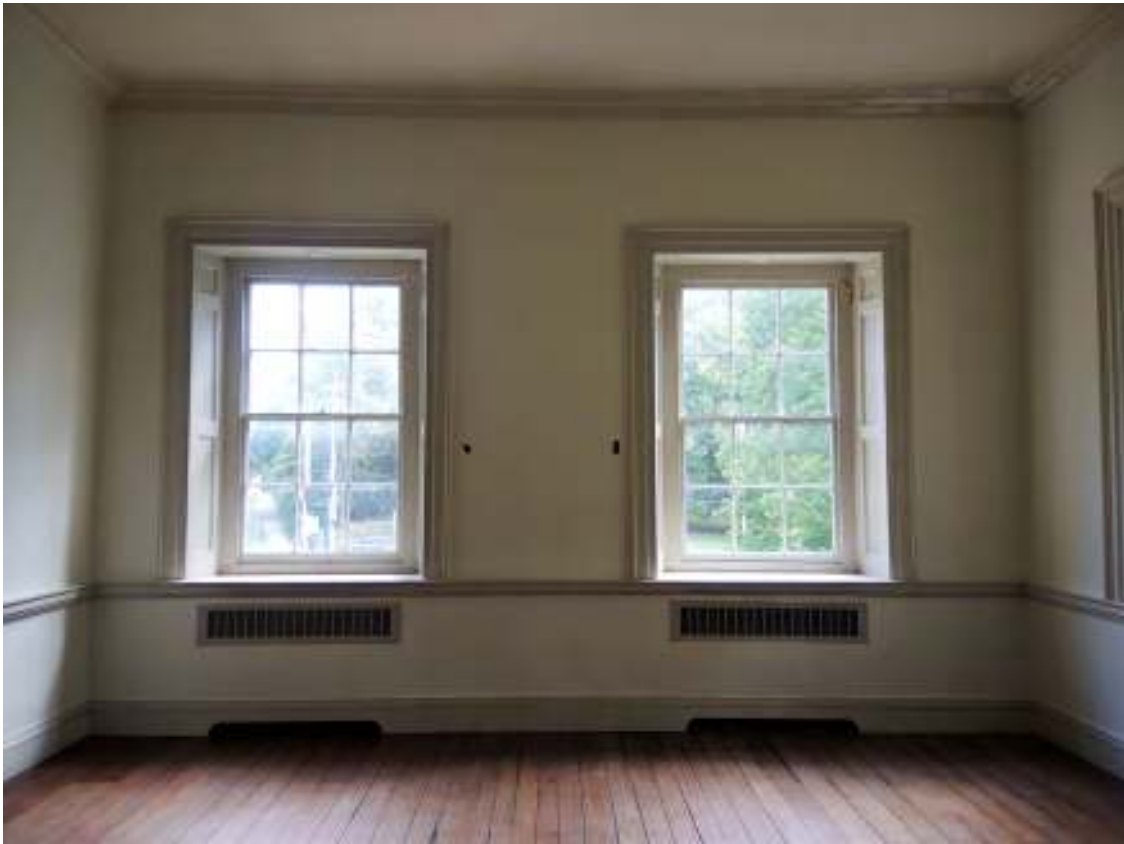
PHOTO 107 - Main Block Interior, Room 201, North Wall; Plaster Molding Damage at East Corner (09-13-2016, NTHP)

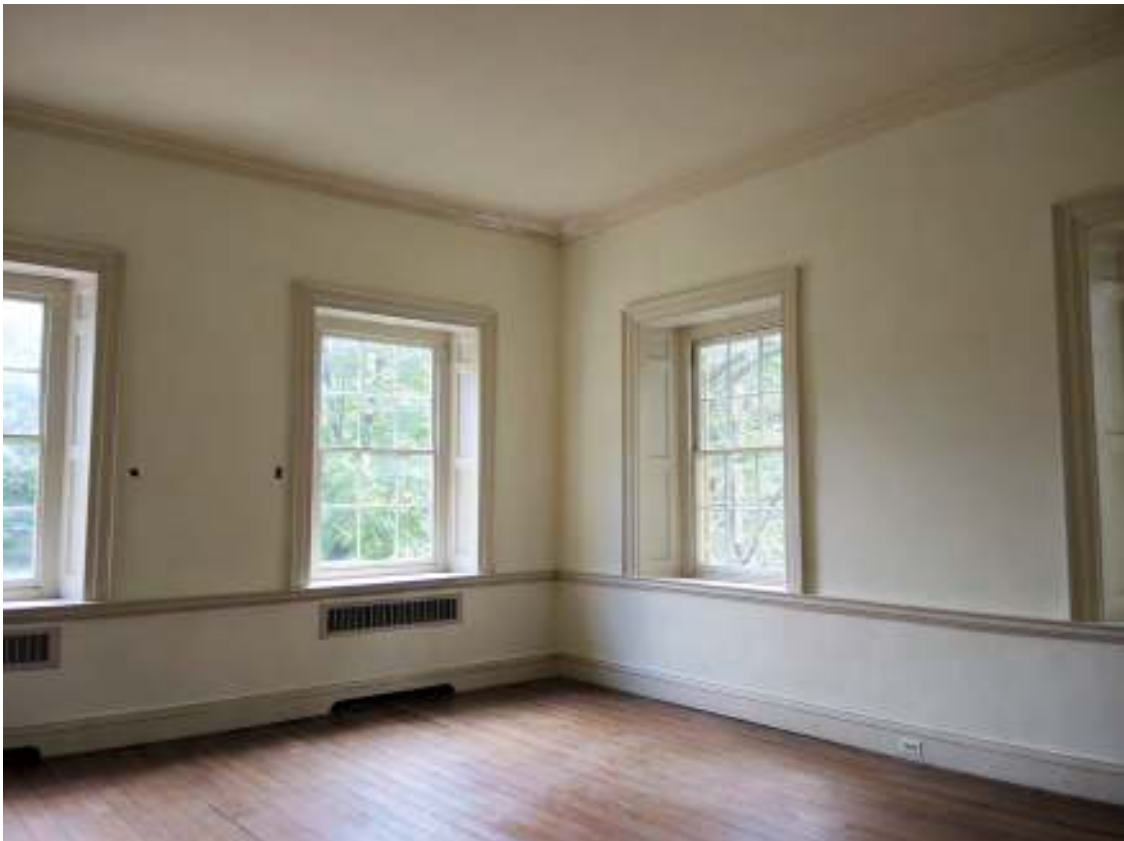
PHOTO 108 - Main Block Interior, Room 201, Northeast Corner; Plaster Molding Damage at Corner (09-13-2016, NTHP)

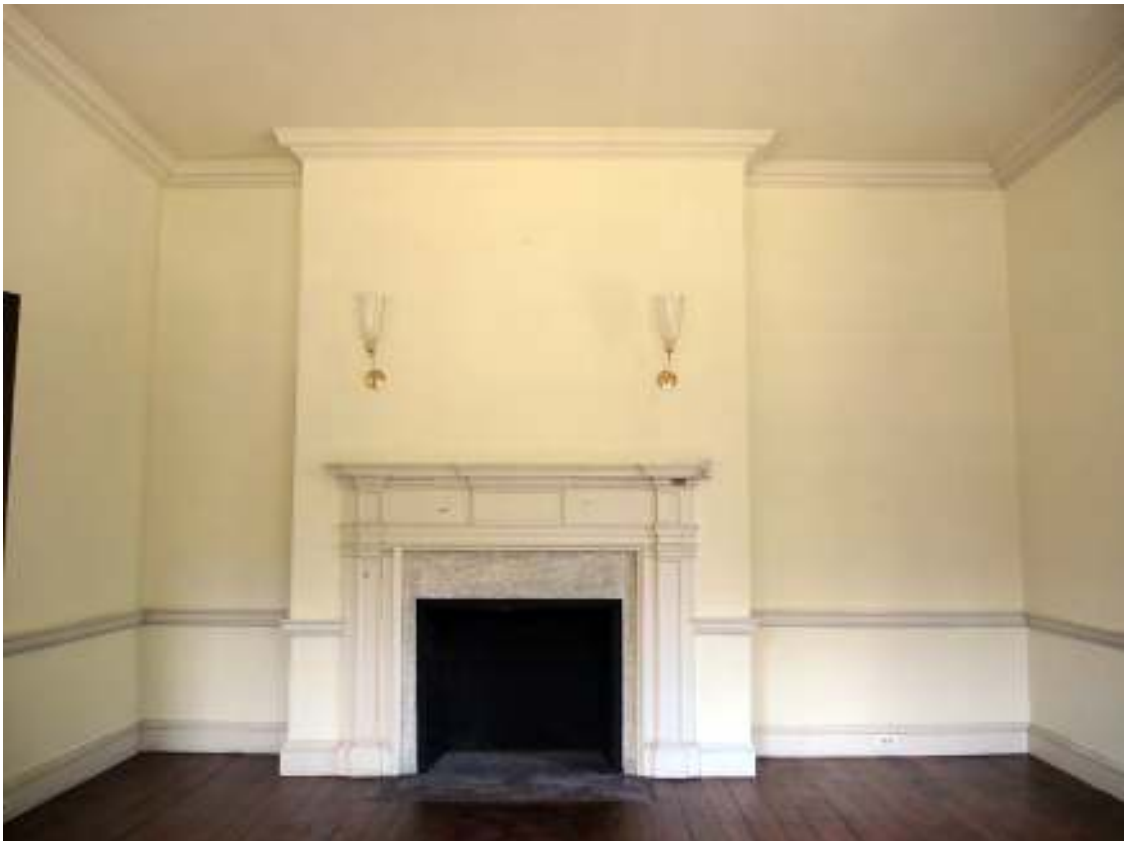
PHOTO 110 - Main Block Interior, Room 203, South Wall; Fireplace Mantel Missing Dentils (09-13-2016, NTHP)
