### Deed of Preservation and Conservation Easement

**UPSALA**  
6430 Germantown Avenue  
Philadelphia, PA 19119

**WHEREAS**, Upsala includes a masonry house (the "House"), comprised of a main block (the "Main Block"), rear ell (the "Ell"), and addition to the Ell (the "Rear Extension") dating to 1798;

**1.2 Baseline Documentation.** Upsala's conservation and preservation values are documented in photographs, floor plans, a site plan, and the Archaeological Report contained or referenced in Exhibit B (hereinafter "Baseline Documentation") incorporated herein by reference, which Baseline Documentation the parties agree provides an accurate representation of the existing conditions of Upsala as of the effective date of this Easement. In the event of any discrepancy between the two (2) counterparts produced, the counterpart retained by Grantee shall control.

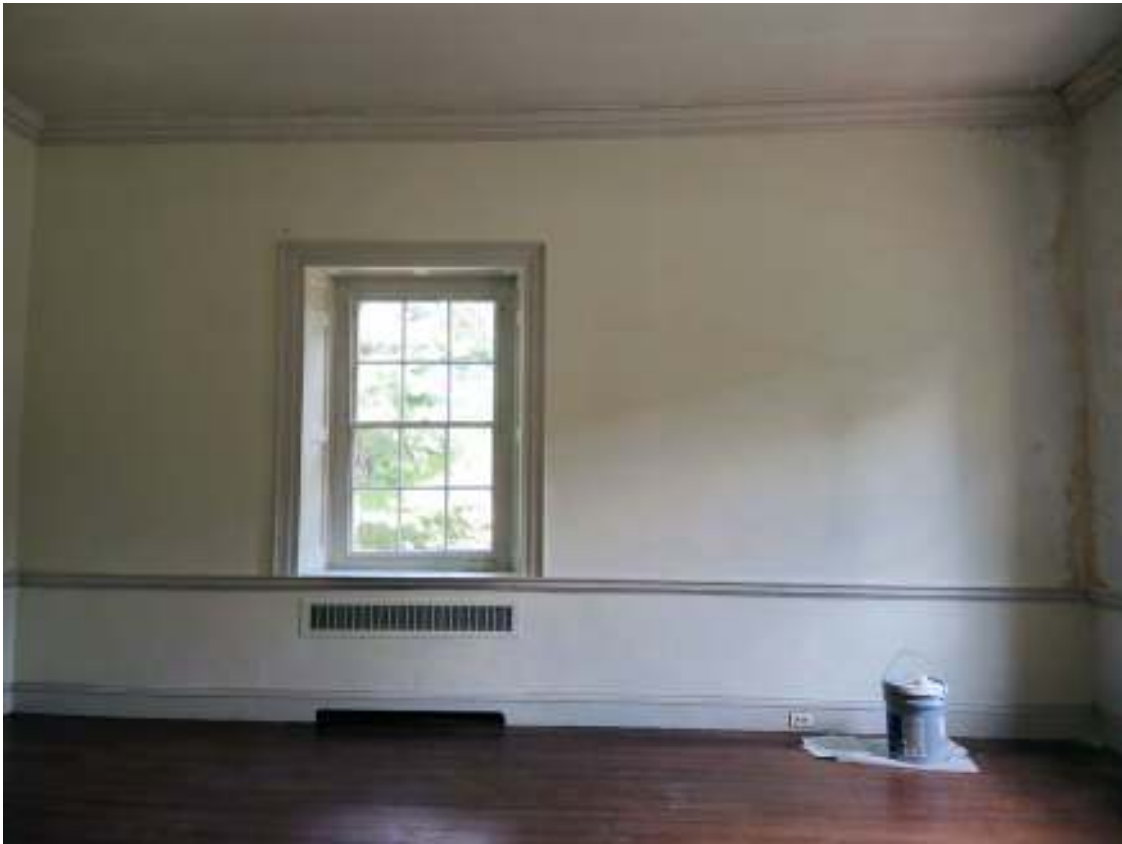
PHOTO 111 - Main Block Interior, Room 203, West Wall; Plaster Wall & Molding Damage at North Wall & Corner (09-13-2016, NTHP)

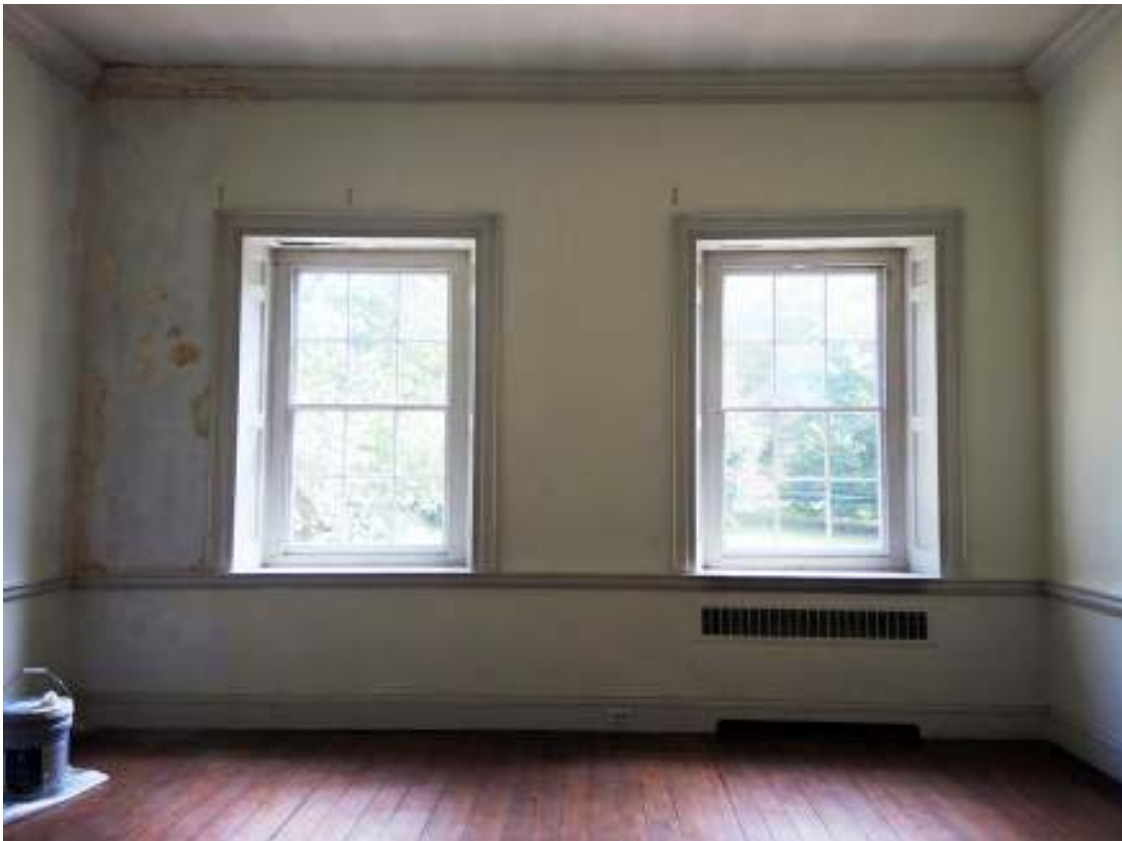
PHOTO 112 - Main Block Interior, Room 203, North Wall; Plaster Wall & Molding Damage at West Corner, Damaged Window Casings (09-1...

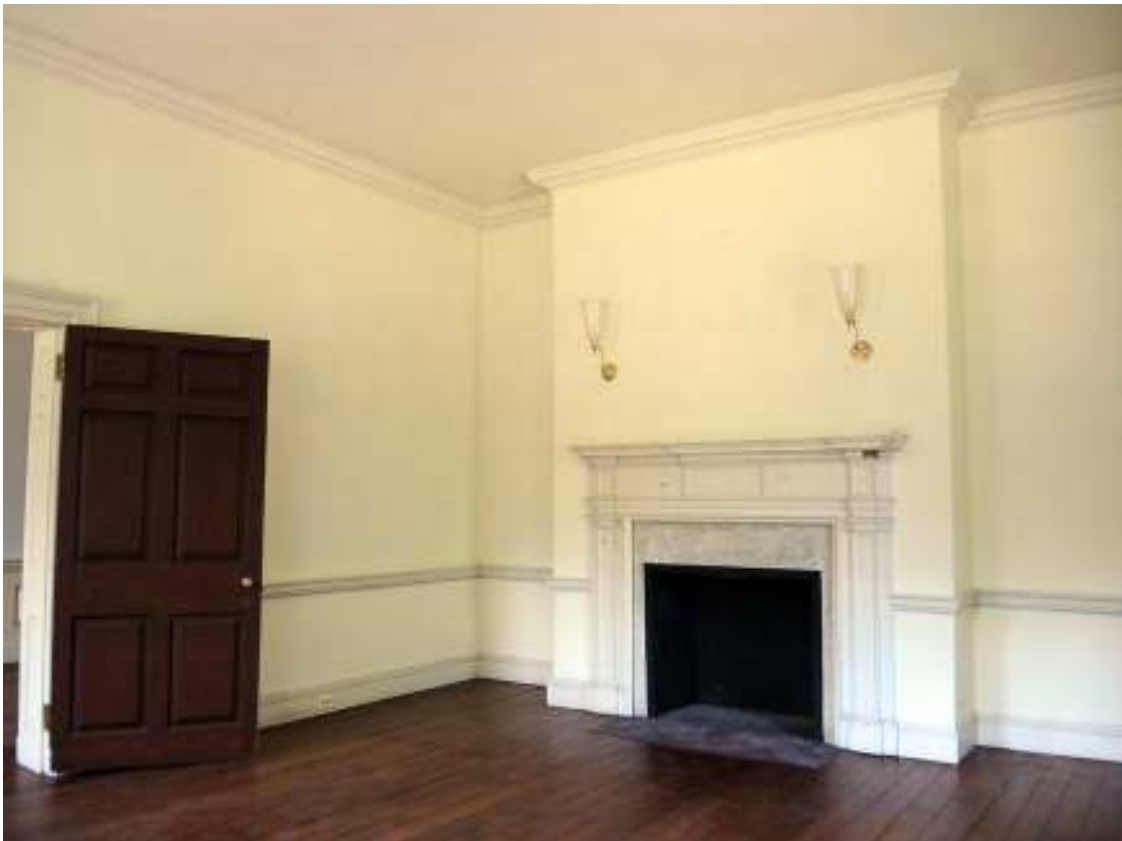
PHOTO 114 - Main Block Interior, Room 203, Southeast Corner; Cracked Plaster Molding and Ceiling on East Wall (09-13-2016, NTHP)

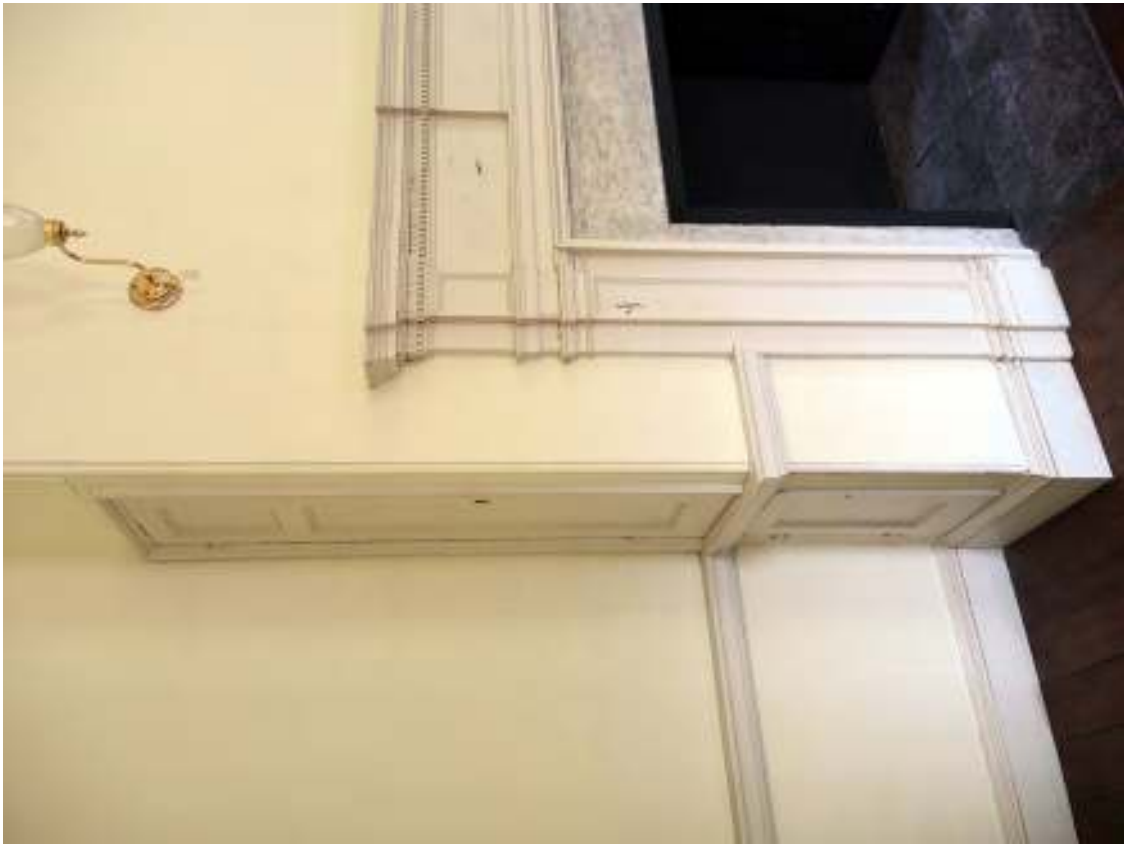
PHOTO 115 - Main Block Interior, Room 203, Detail of Cabinet; Flaking Paint on Wood Fireplace Mantel (09-13-2016, NTHP)

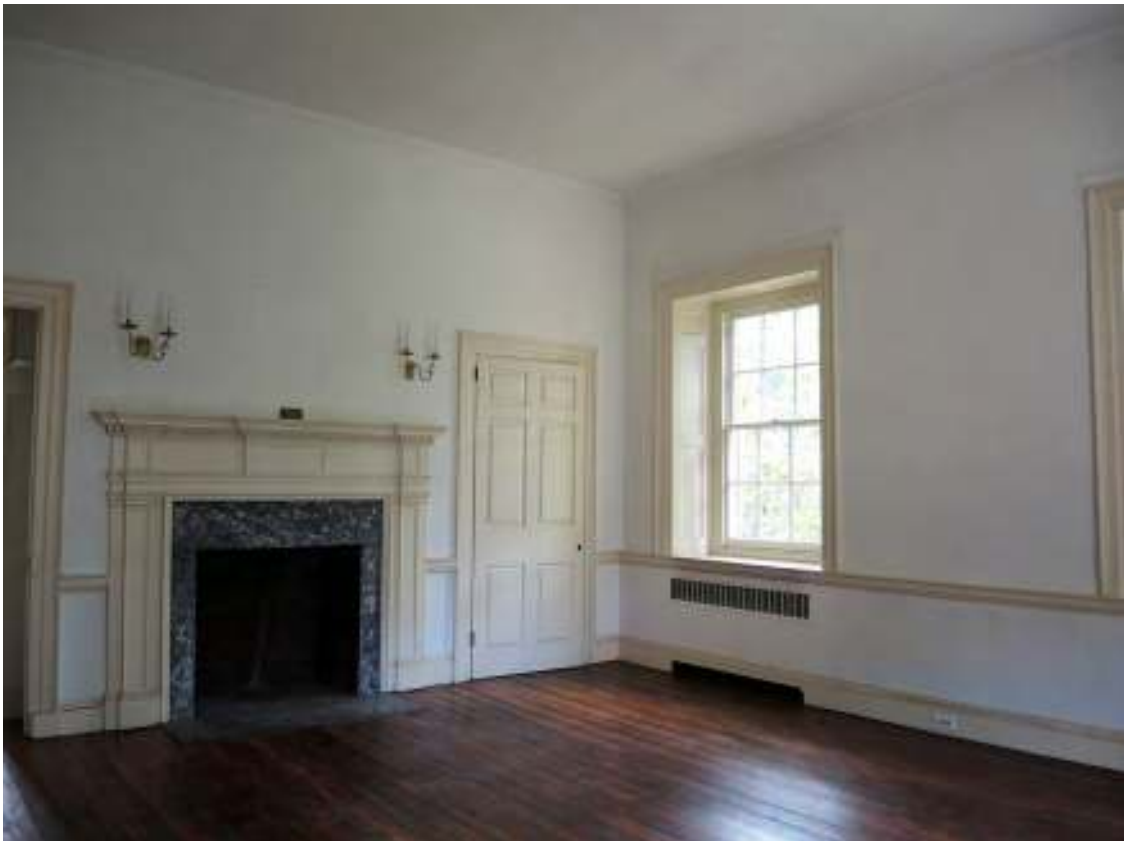
PHOTO 116 - Main Block Interior, Room 204, Northeast Corner; Cracks in Stone Fireplace Surround, Cracked Plaster on Walls and Molding...

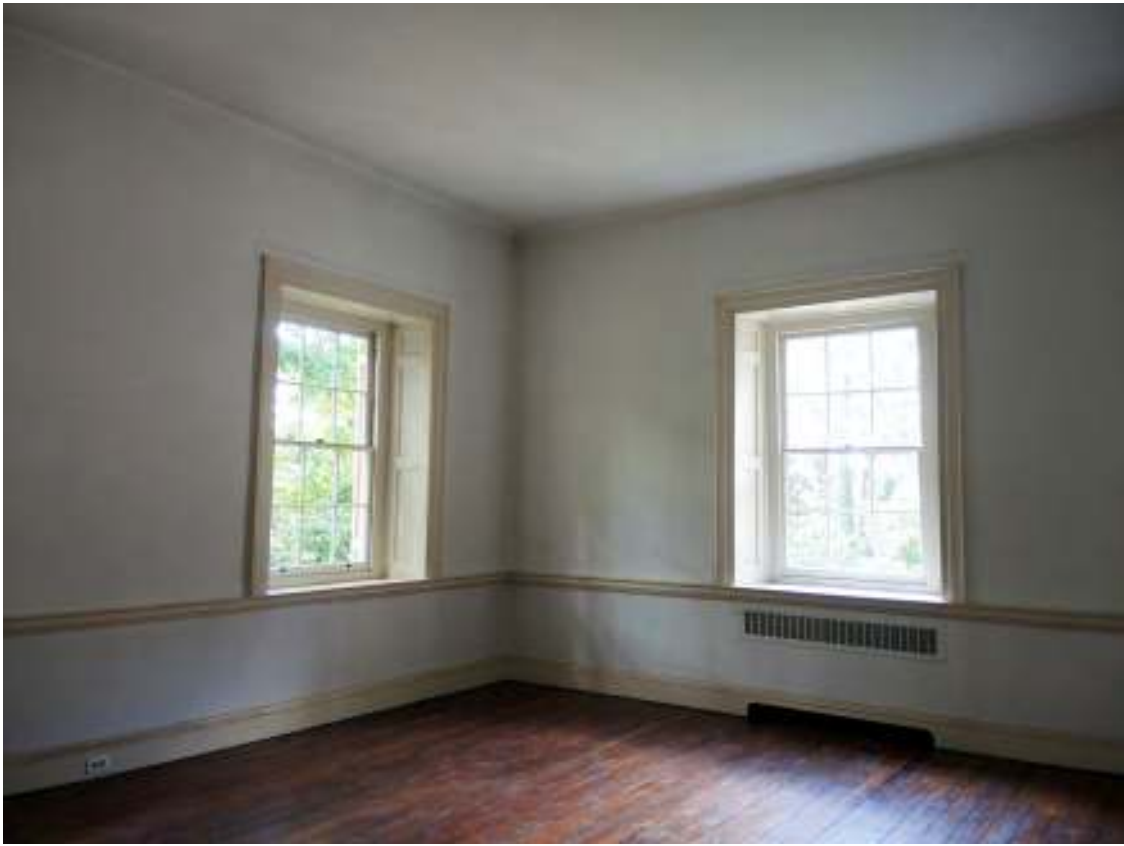
PHOTO 117 - Main Block Interior, Room 204, Southeast Corner; Cracked Plaster above South Window (09-13-2016, NTHP)

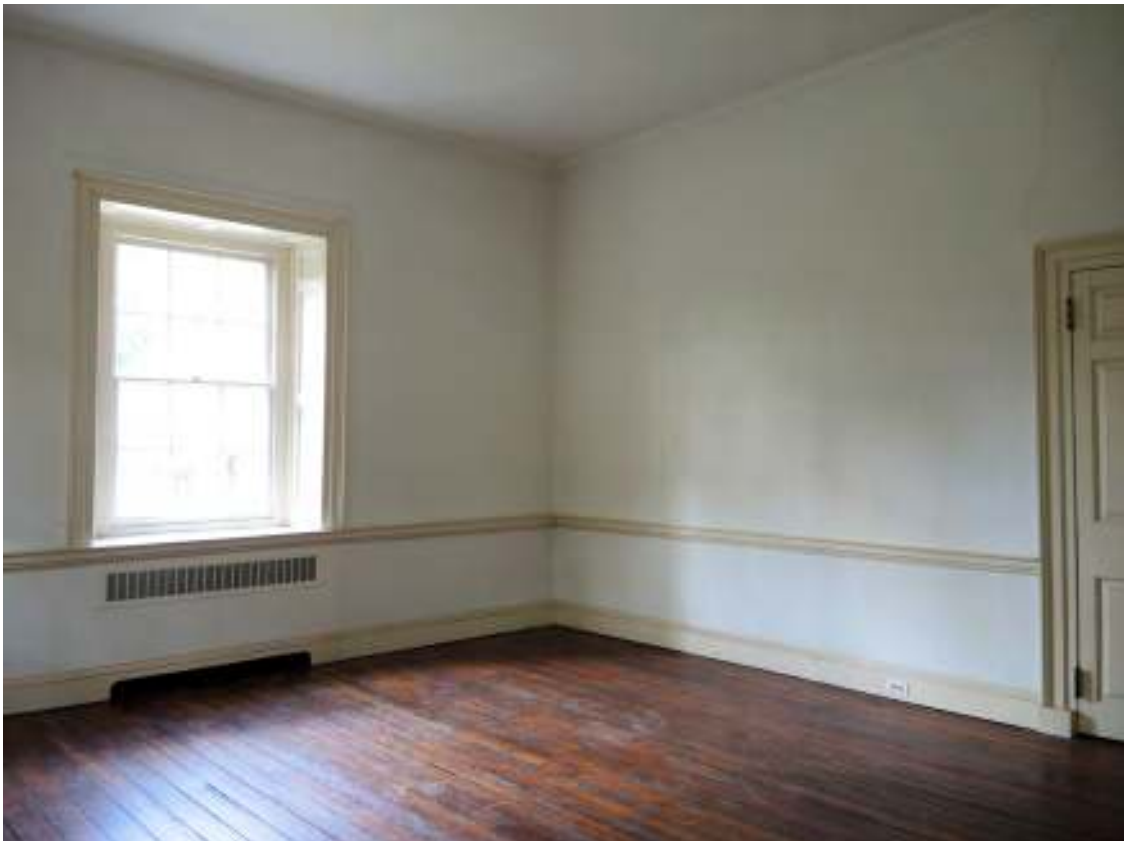
PHOTO 118 - Main Block Interior, Room 204, Southwest Corner; Cracked Plaster Along Ceiling at South Wall (09-13-2016, NTHP)

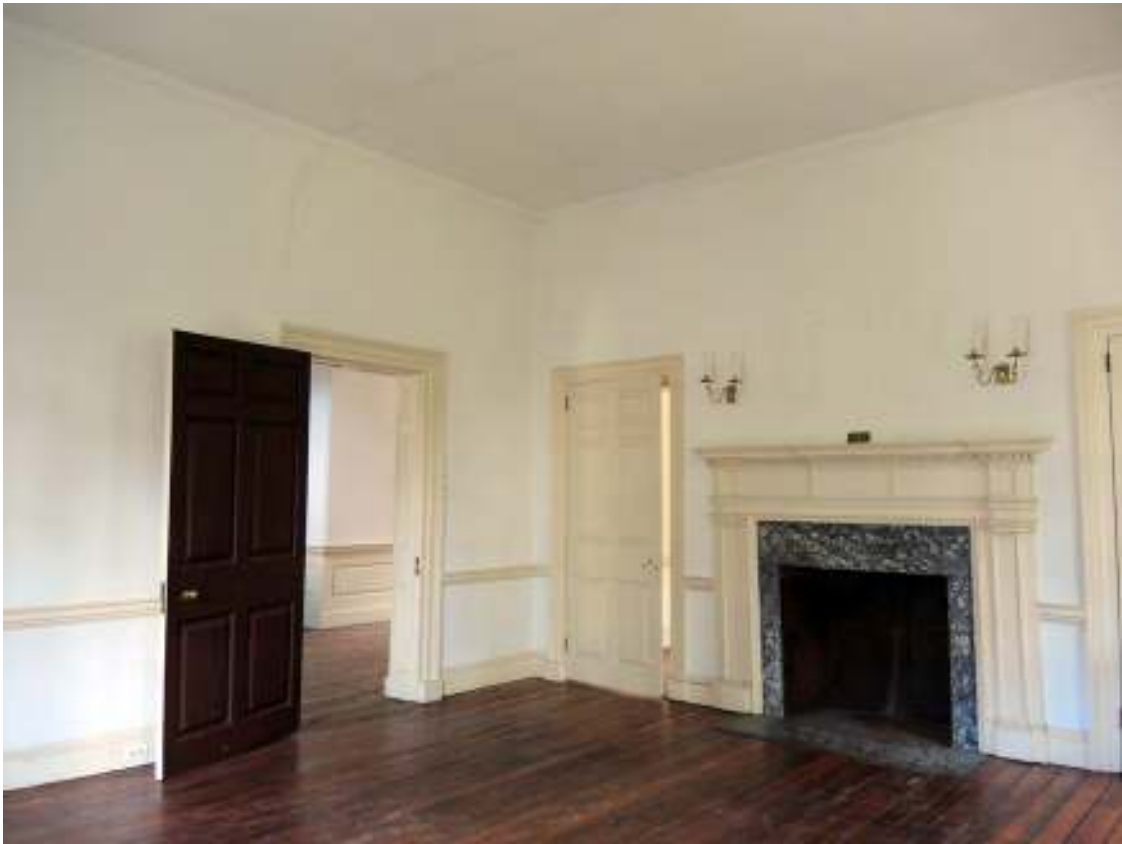
PHOTO 119 - Main Block Interior, Room 204, Northwest Corner; Cracked Plaster from Top of West Door to Across the Center of the Ceiling ...

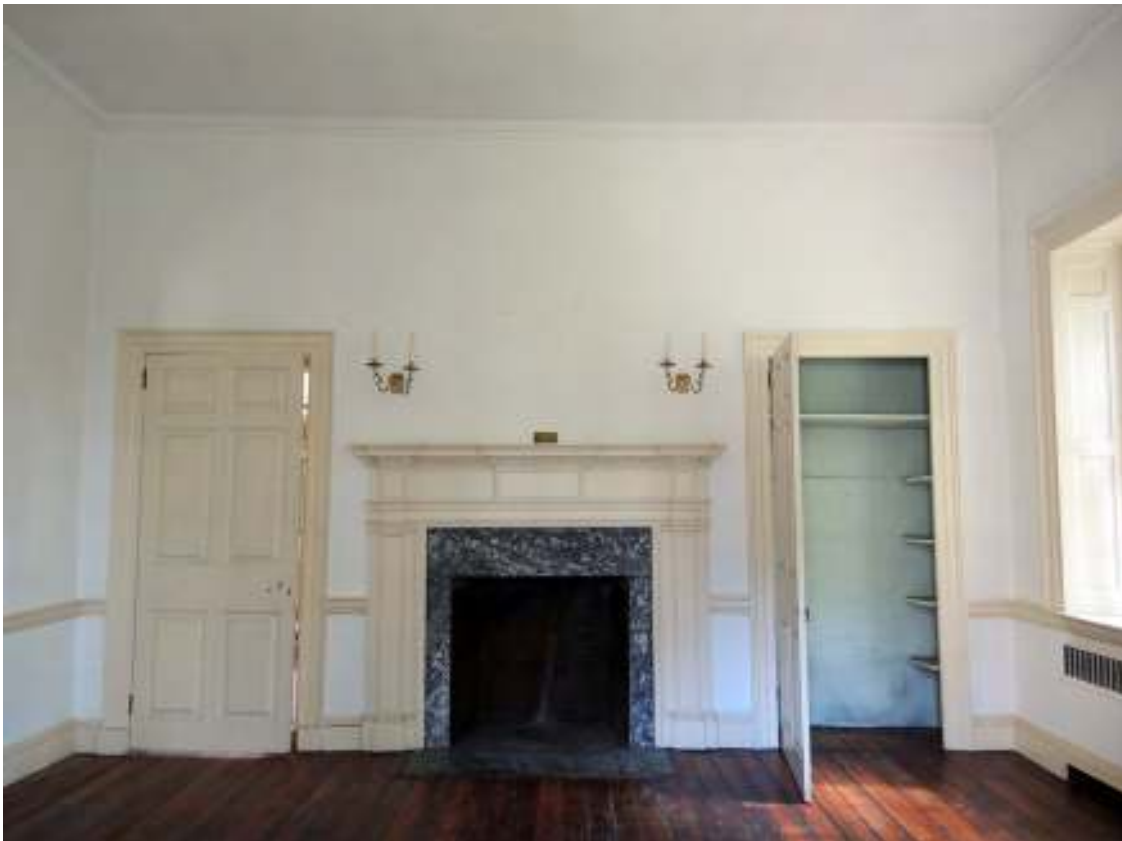
PHOTO 120 - Main Block Interior, Room 204, North Wall; Cracked Plaster from Ceiling to Wall above East Door (09-13-2016, NTHP)

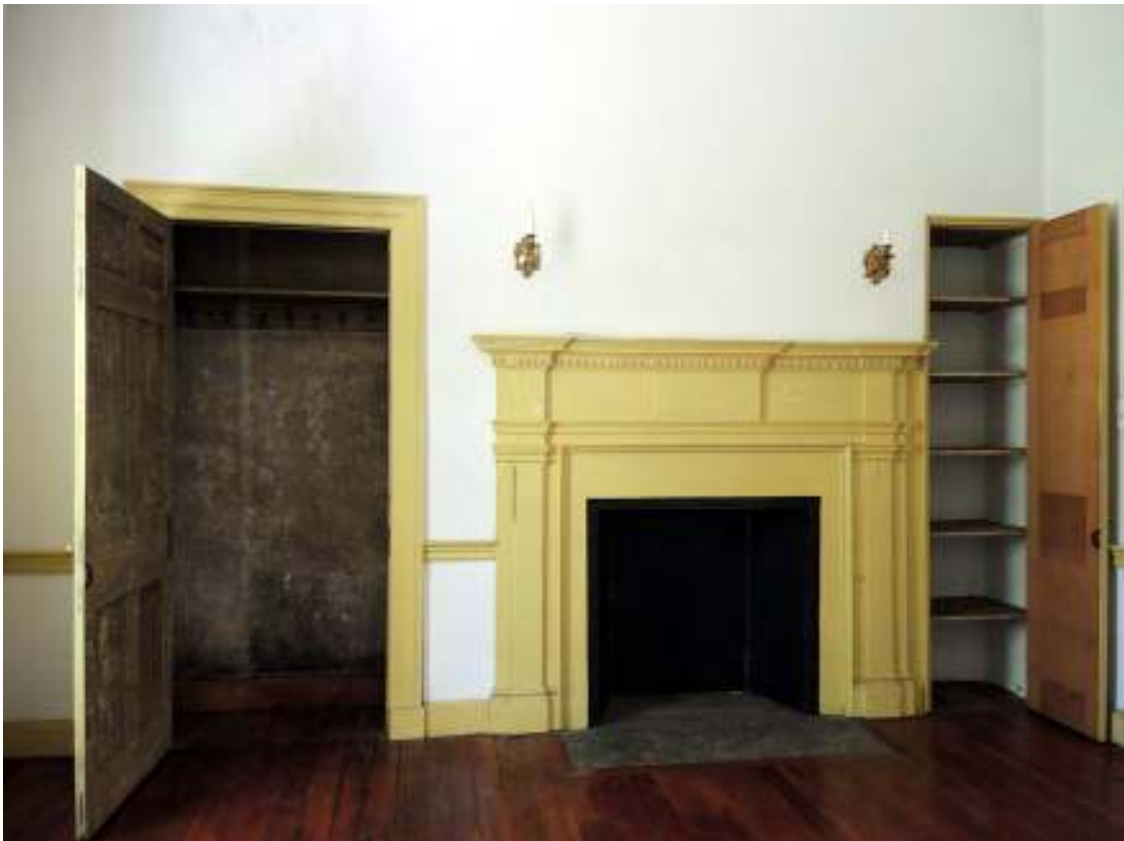
PHOTO 125 - Main Block Interior, Room 205, North Wall; Damaged Plaster above West Door, Fireplace Surround Split Wood, Peeling Paint...

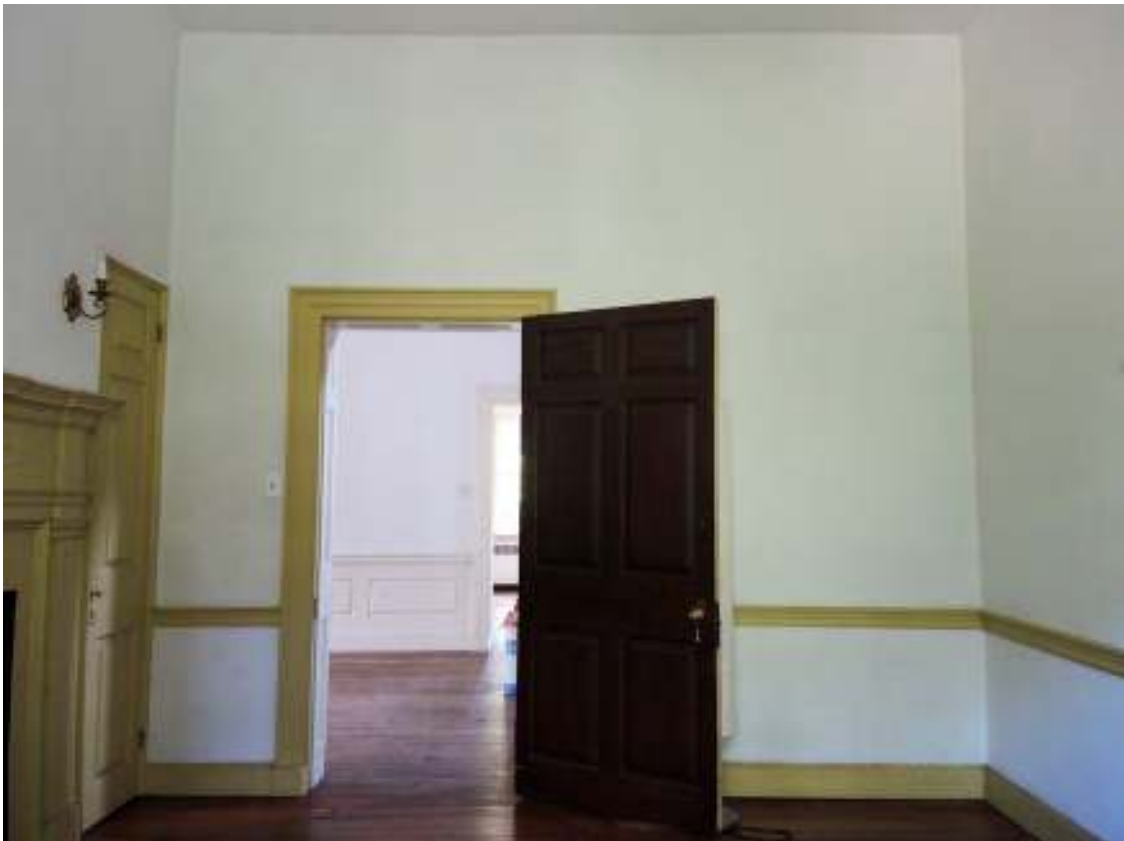
PHOTO 127 - Main Block Interior, Room 205, East Wall; Cracked Plaster at top of East Wall (09-13-2016, NTHP)

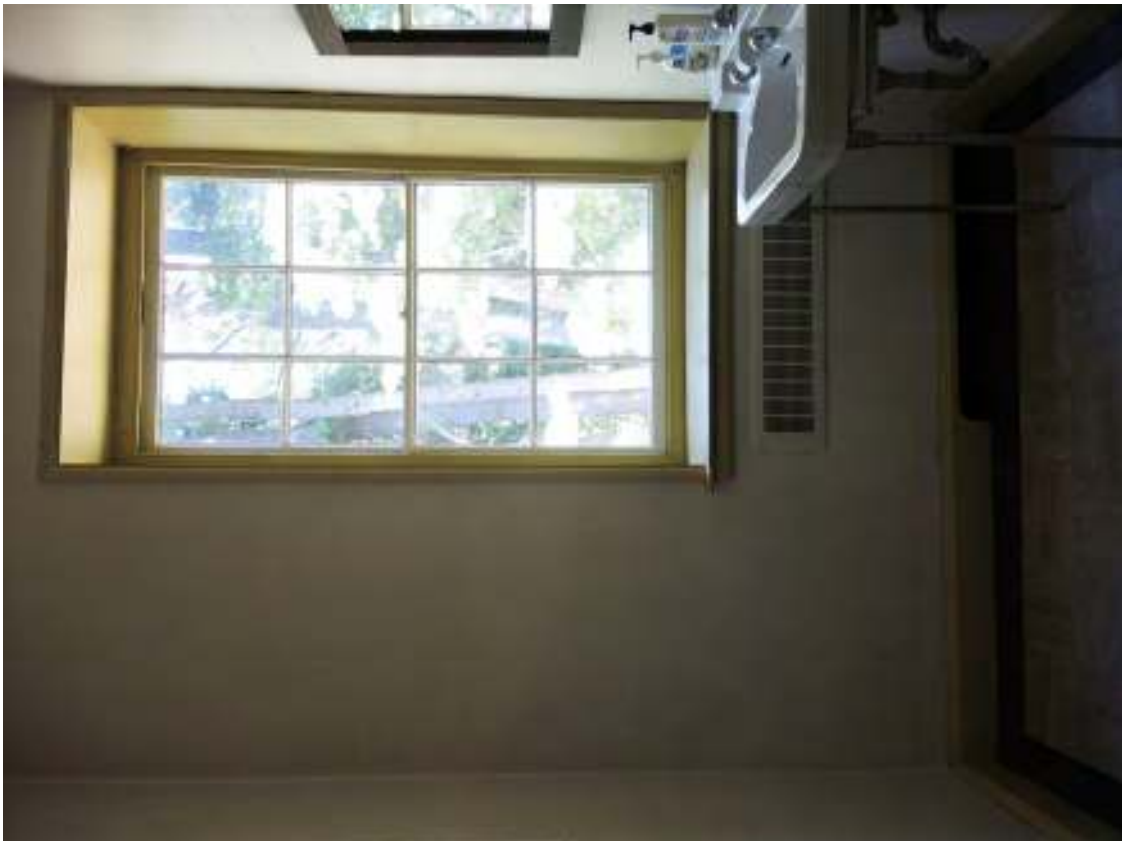
PHOTO 129 - Main Block Interior, Room 205A, West Wall; Ceiling Damage, Cracked Plaster Above Sink on North Wall (09-14-2016, NTHP)

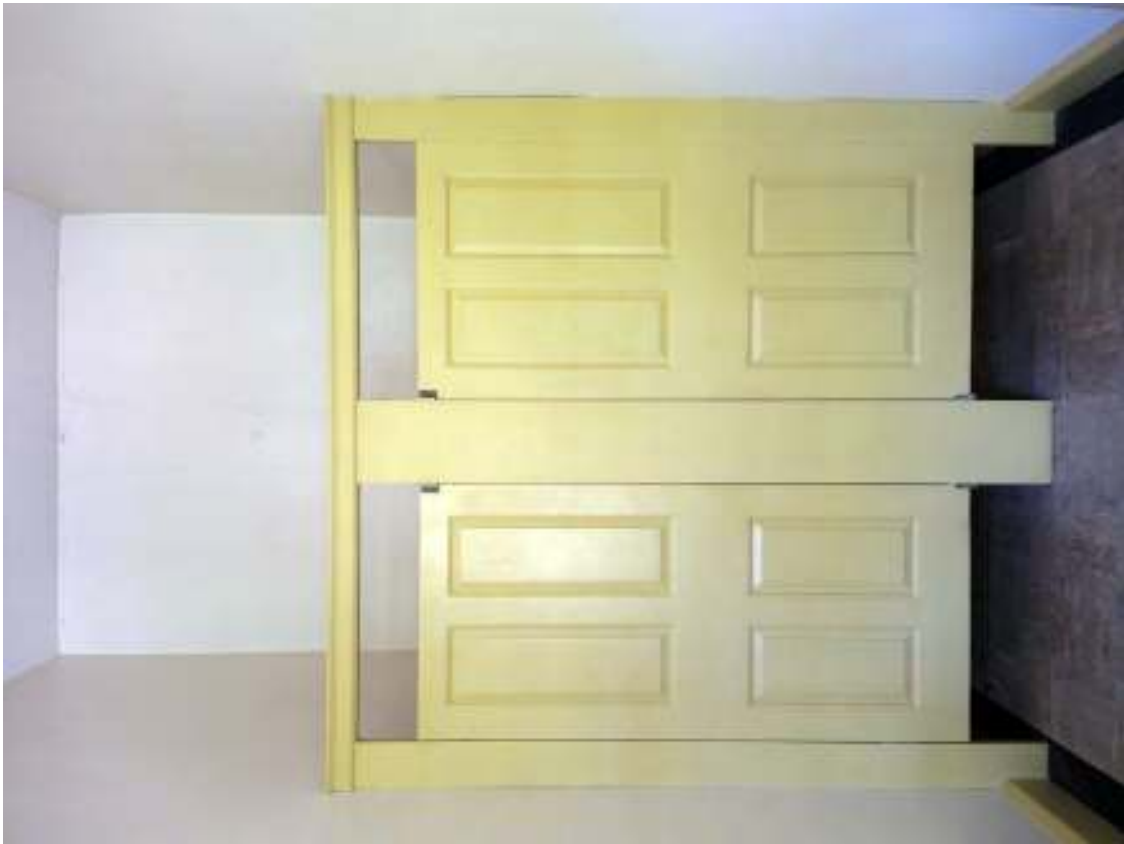
PHOTO 130 - Main Block Interior, Room 205A, East Wall; Two Cracks from Top of Wall Down, Plaster Depression at Top of Wall (09-14-20...

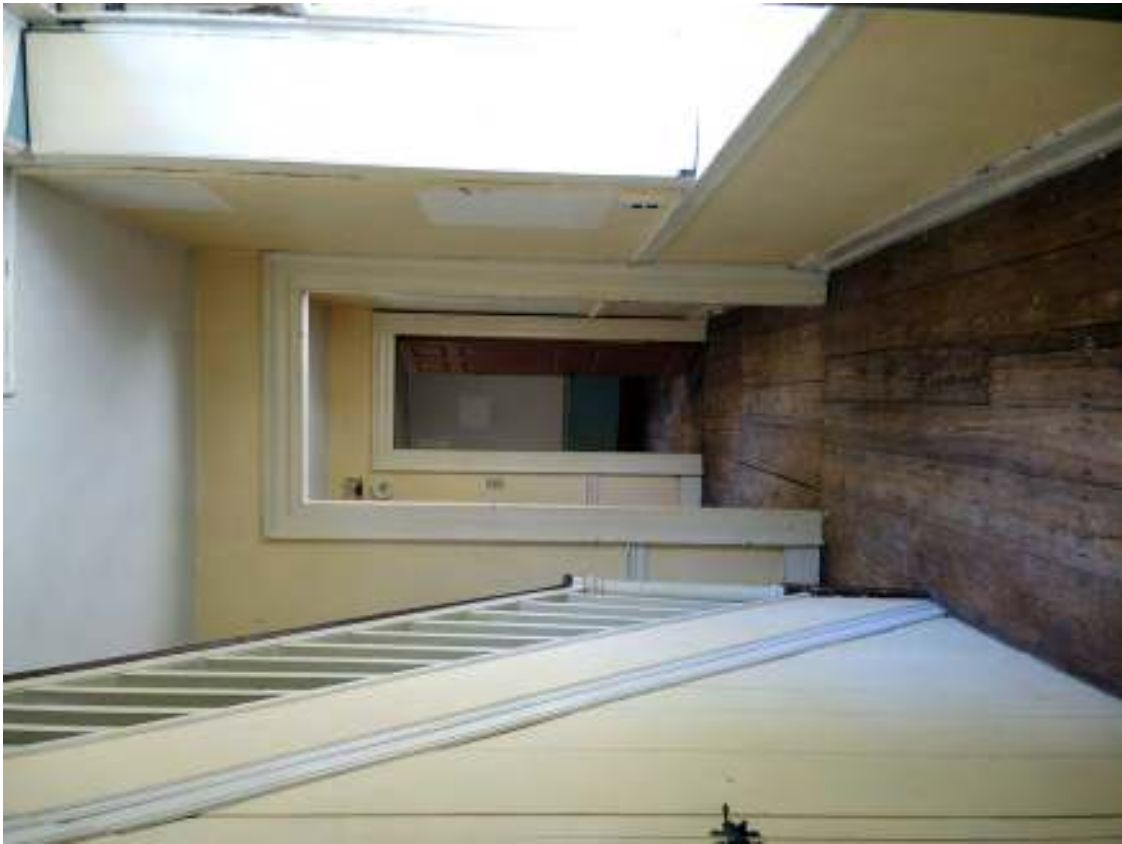
PHOTO 148 - Ell Interior, Room 209, Looking Northeast; Damaged Wood Floors (09-14-2016, NTHP)

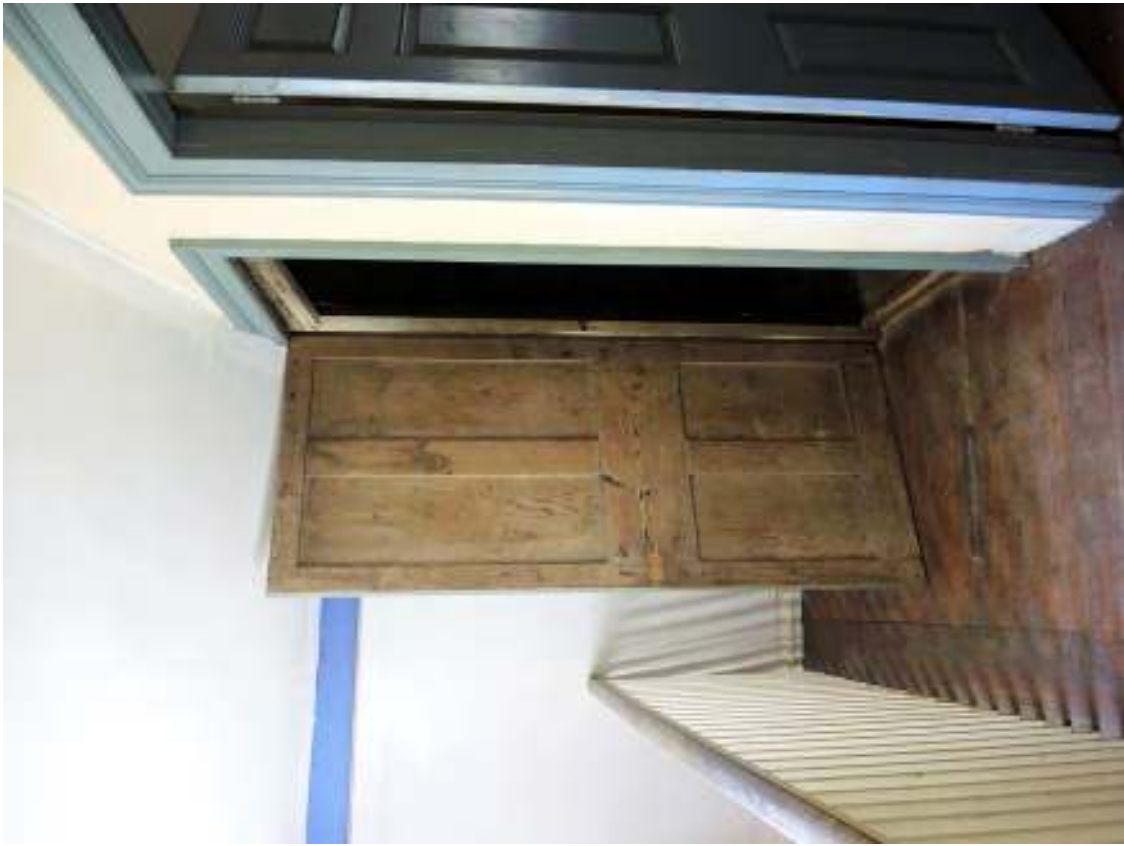
PHOTO 150 - Rear Extension Interior, Room 209A, Looking Southwest; Damaged Wood Floors (09-14-2016, NTHP)

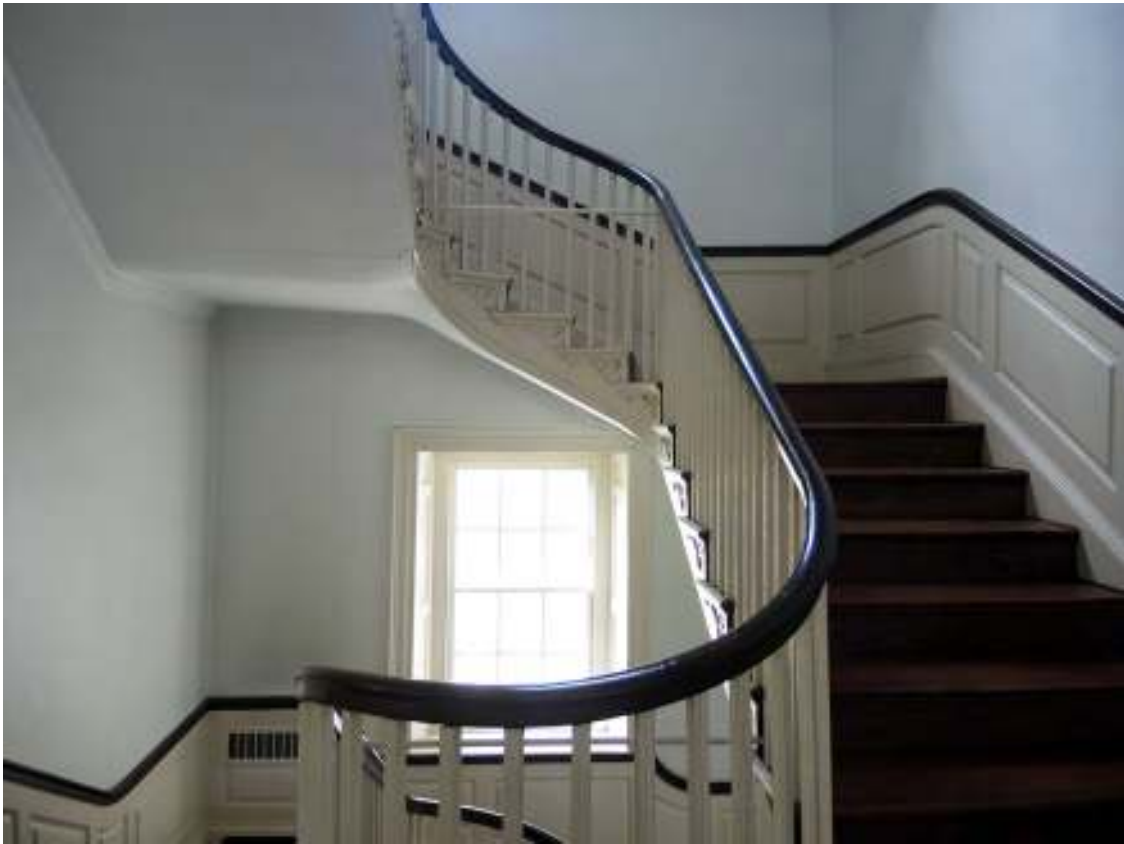
PHOTO 154 - Main Block Interior, Room 202, Looking Southwest; Damage to Plaster Above Window and Wood Window Trim (09-13-2016, ...

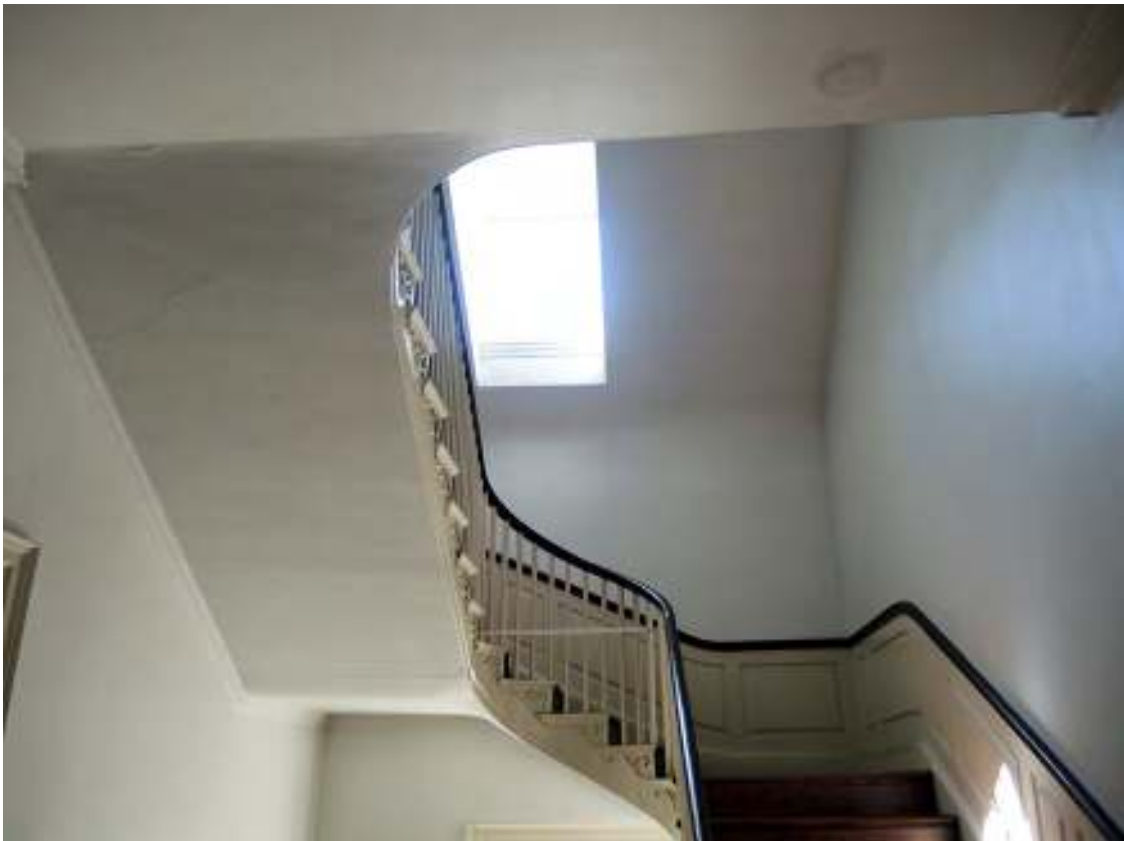
PHOTO 155 - Main Block Interior, Room 202, Looking Southwest; Plaster Damage on West Ceiling, Cracked Plaster Underside of Staircase...

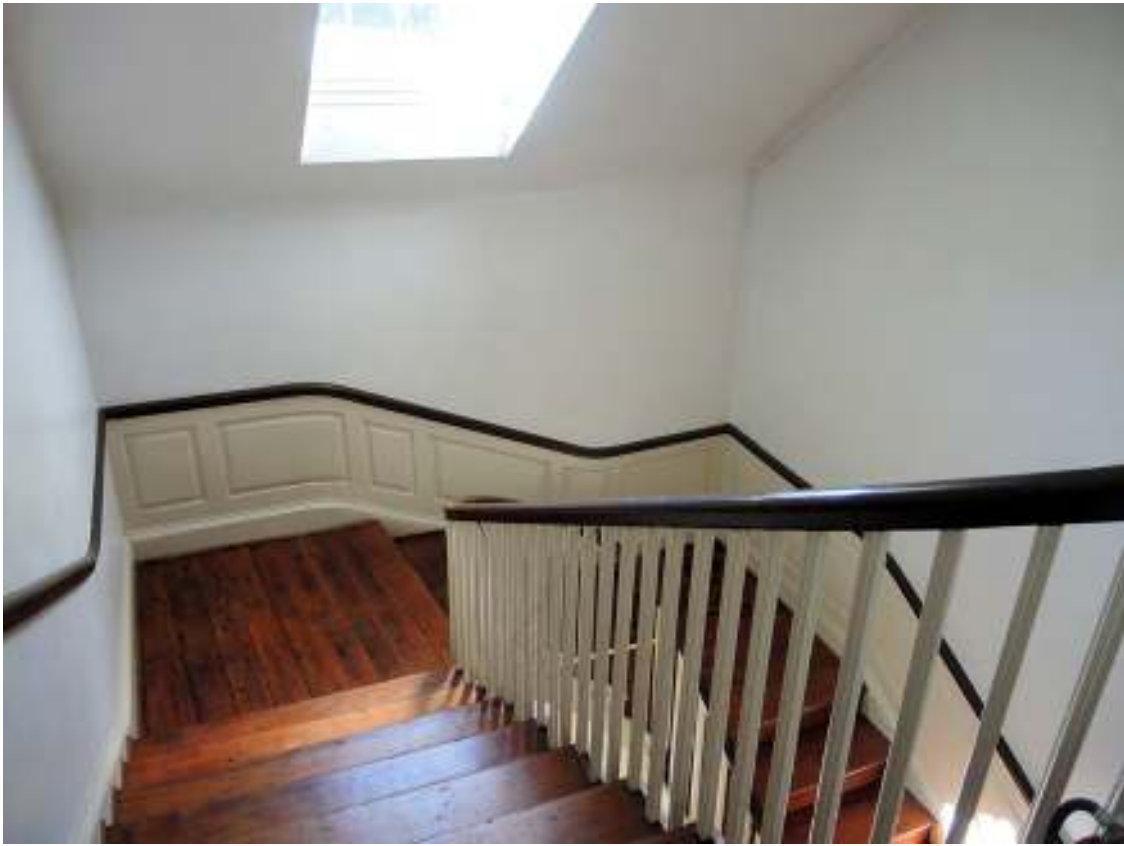
PHOTO 158 - Main Block Interior, Room 302, Looking Southwest; Cracked Plaster in West Corner, Plaster Damage at Dormer (09-14-2016,...
