### Deed of Preservation and Conservation Easement

**UPSALA**  
6430 Germantown Avenue  
Philadelphia, PA 19119

**WHEREAS**, Upsala includes a masonry house (the "House"), comprised of a main block (the "Main Block"), rear ell (the "Ell"), and addition to the Ell (the "Rear Extension") dating to 1798;

**1.2 Baseline Documentation.** Upsala's conservation and preservation values are documented in photographs, floor plans, a site plan, and the Archaeological Report contained or referenced in Exhibit B (hereinafter "Baseline Documentation") incorporated herein by reference, which Baseline Documentation the parties agree provides an accurate representation of the existing conditions of Upsala as of the effective date of this Easement. In the event of any discrepancy between the two (2) counterparts produced, the counterpart retained by Grantee shall control.

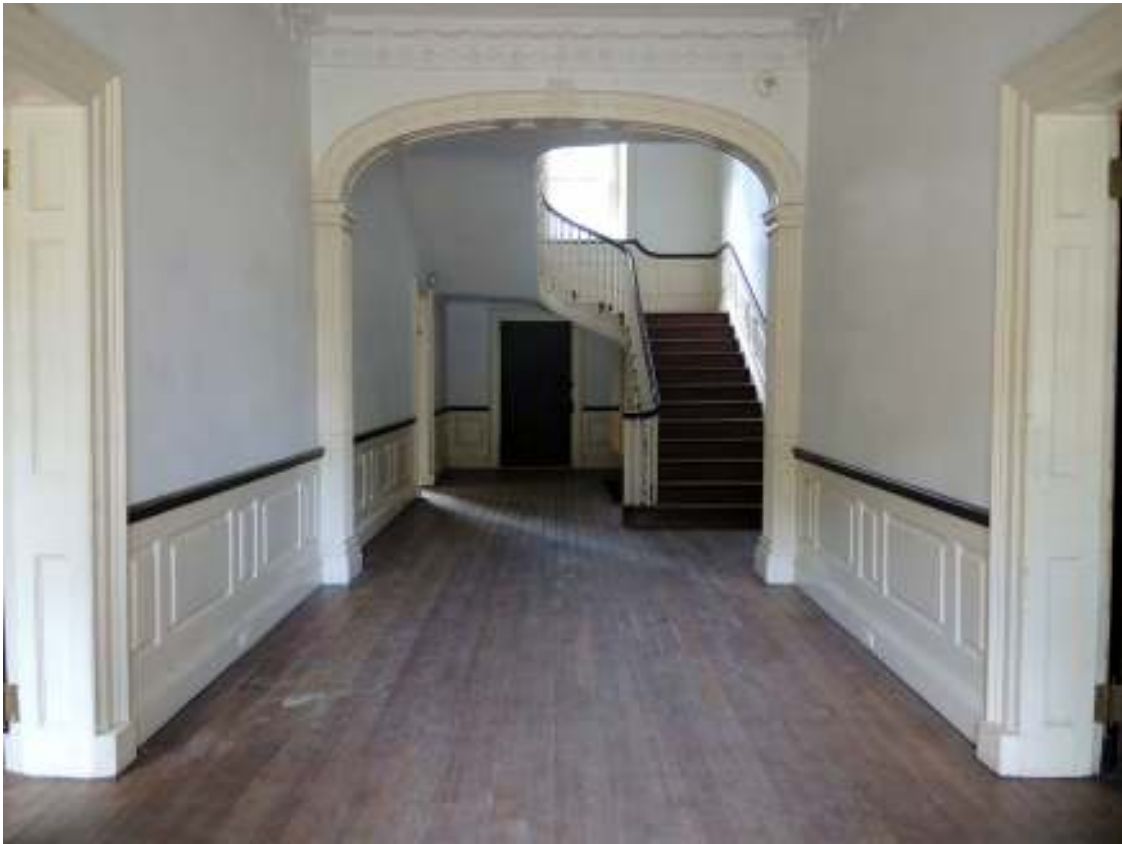
PHOTO 047 - Main Block Interior, Room 102, Looking Southwest; Wooden Arch Slight Separation from Wall (09-13-2016, NTHP)

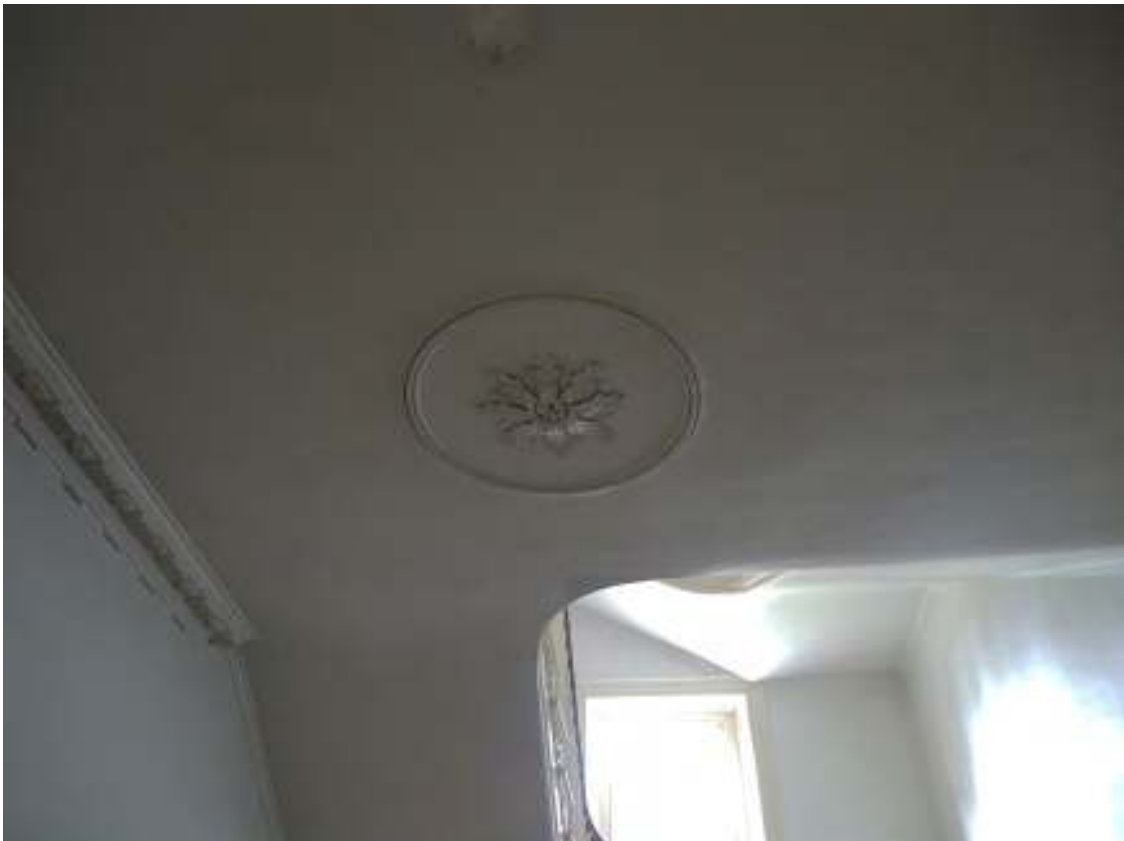
PHOTO 058 - Main Block Interior, Room 102, Detail of Plaster Medallion; Plaster Ceiling Discoloration Northeast of Ceiling Medallion (09-13...

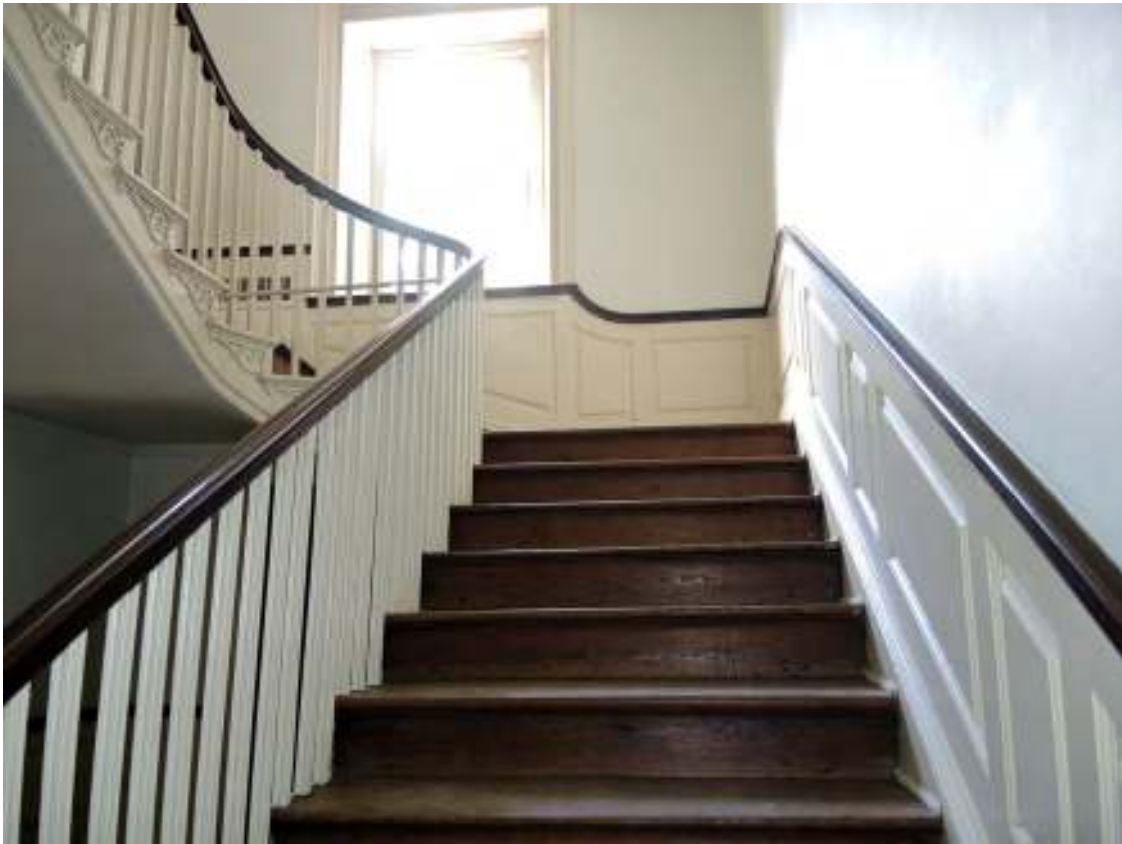
PHOTO 059 - Main Block Interior, Room 102, Looking Southwest; Hole in Floors at Northwest Corner of First Landing (09-13-2016, NTHP)

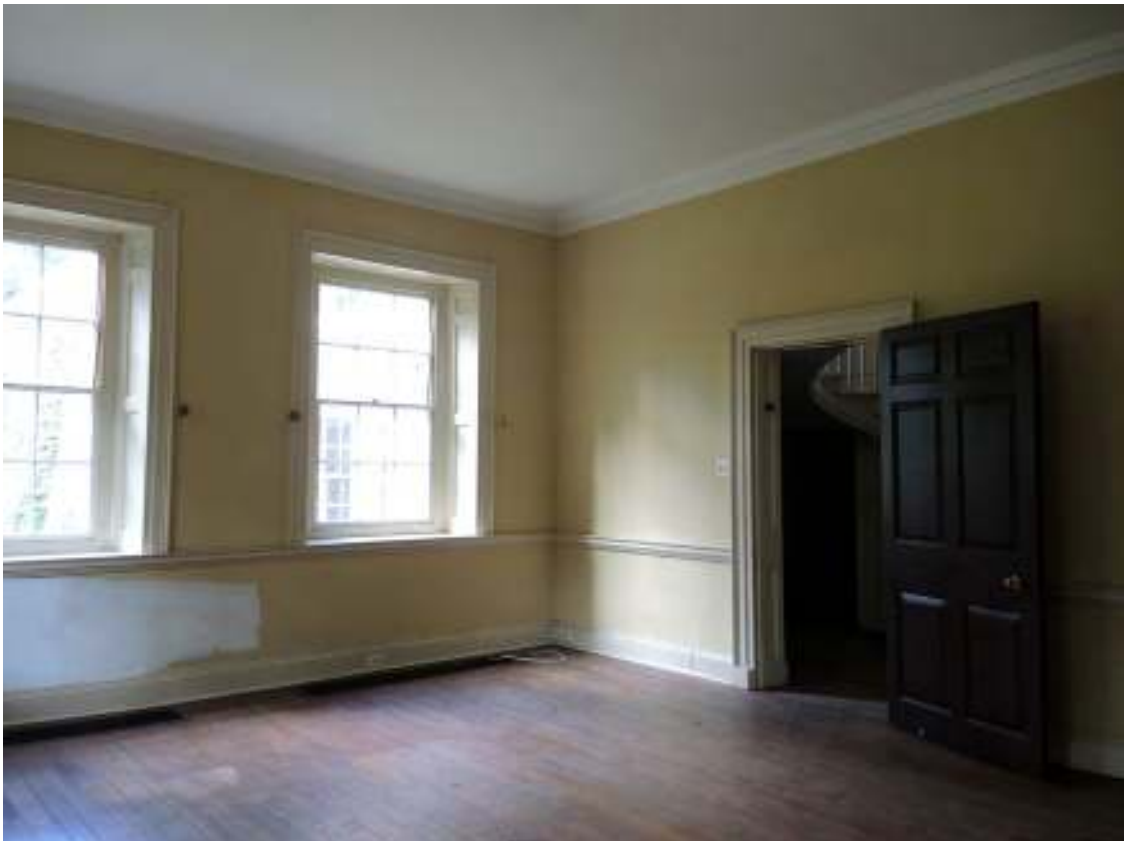
PHOTO 076 - Main Block Interior, Room 104, Southwest Corner; Small Holes in Floor along South Wall (09-13-2016, NTHP)

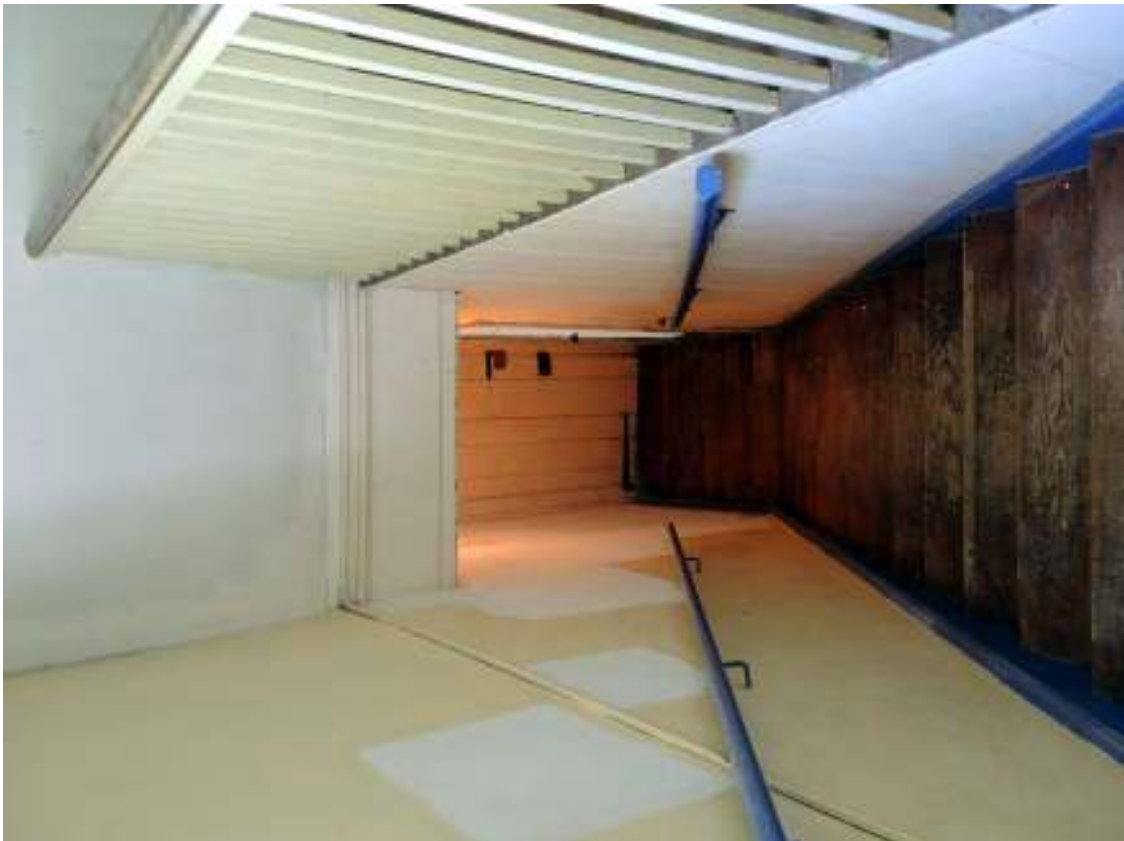
PHOTO 153 - Rear Extension Interior, Room 209, Looking Southwest; Uneven East Wall (09-14-2016, NTHP)
